FORGE 58-32 Injection and Packer Performance - April 2019

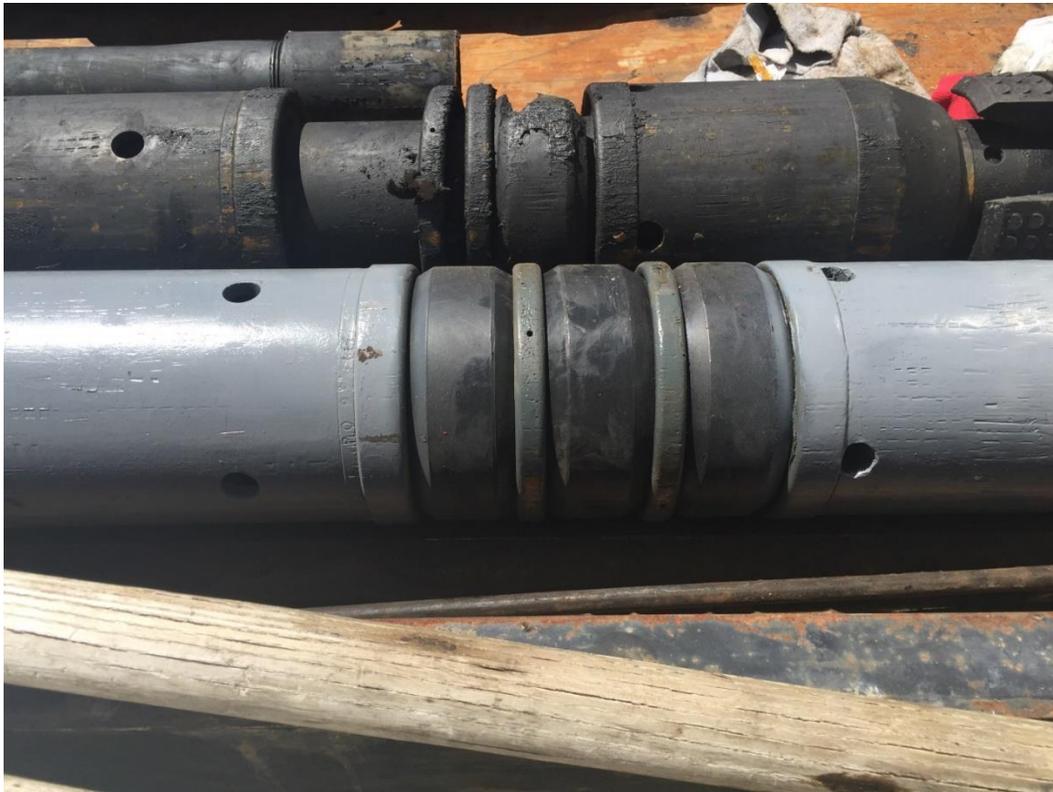
Figure 1. This image shows a new packer element (bottom) and the retrieved packer element from Zone 1 (run above the perforations at 6964 to 6974 ft measured depth).

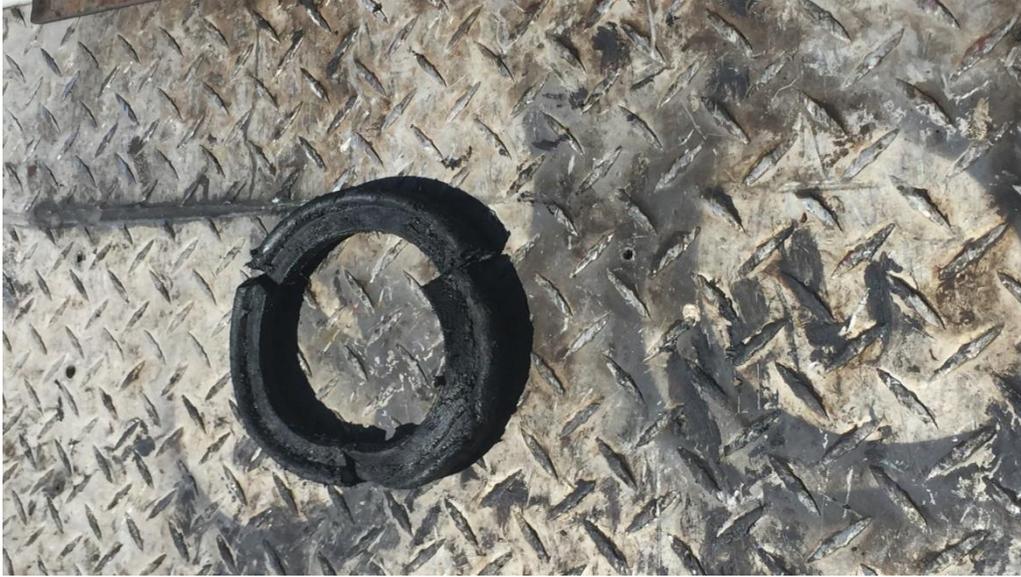
Figure 2. This photograph was taken on May 3, 2019 after recovery of the packer from above Zone 3. It shows a failed sealing element. An observer reported: "When packer pulled above the slips the broken ring fell into our hands." There was a significant amount of drag while recovering this tool (refer to Figure 4).

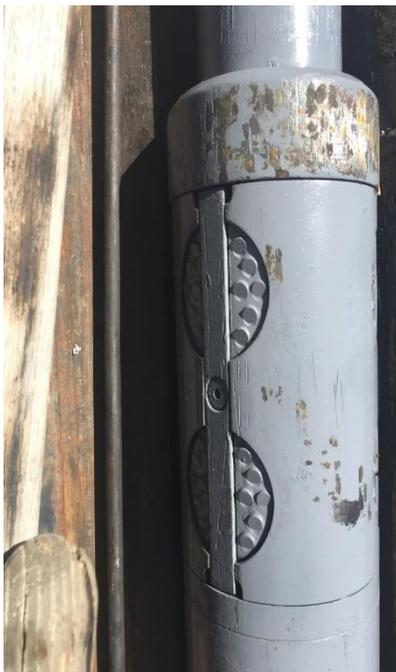
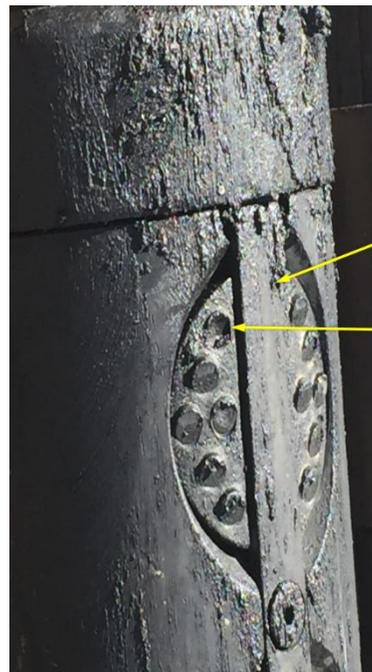
Figure 3. For the packer shown in Figure 2, not only the rubbers were damaged, but the slips had failed. The photograph at left shows new slips. The photograph at right shows the upper slips on the packer recovered from Zone 3 on May 3, 2019. The arrows highlight the damage.

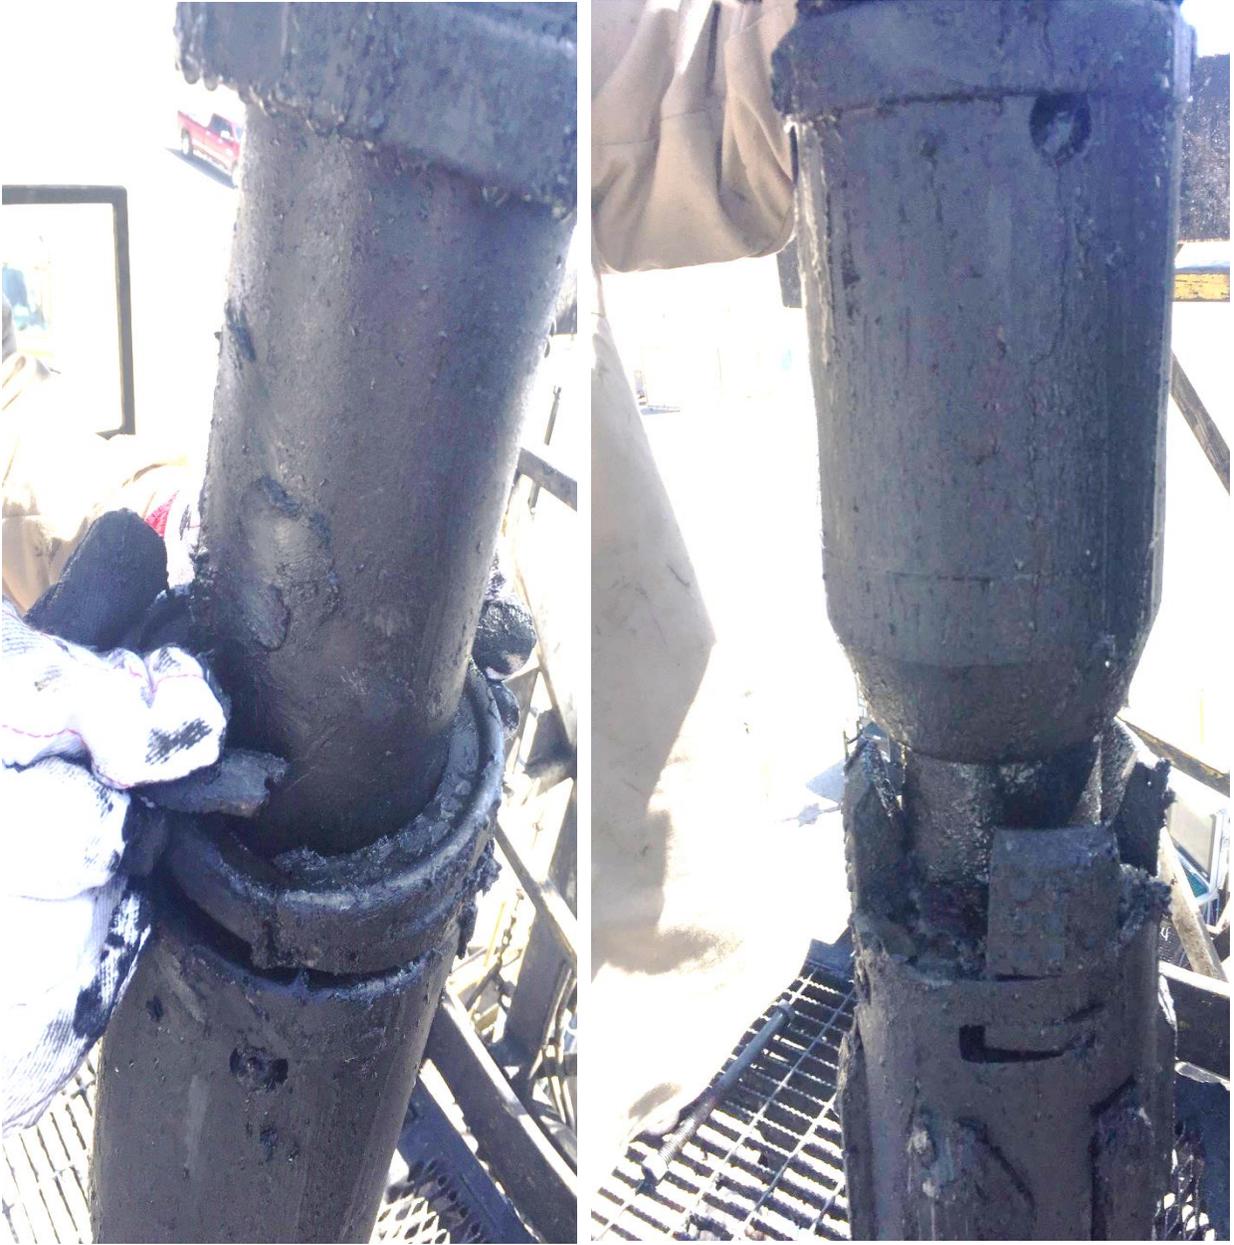
Figure 4: Two views of the Zone 3 packer after recovery. The broken rings caused significant drag.
