### **EGS Collab: Downhole Camera Survey Procedure During Injection on 4850L**

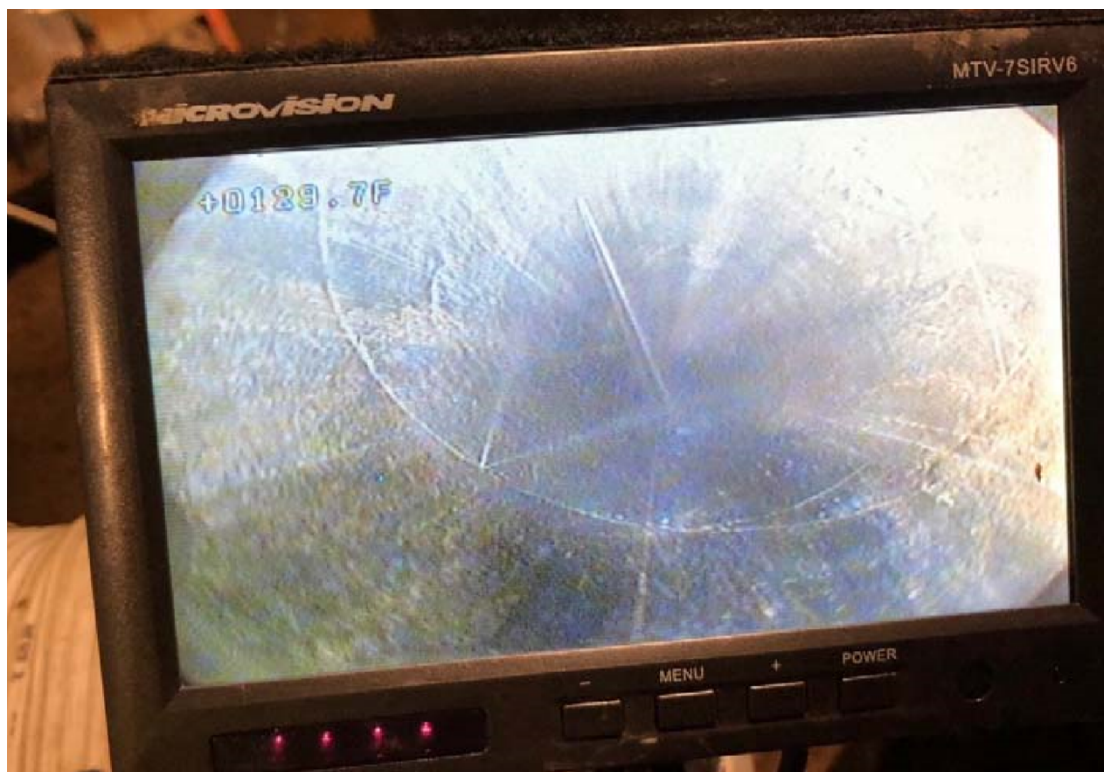
On May 25<sup>th</sup>, water was injected at the previously-stimulated (hydrofractured) depth of 164 feet in E1-I. During this injection, there was significant hydraulic connection between E1-I and E1-P, on the order of ~1.5 liters per minute into E1-P when pumping 5 liters per minute into E1-I. Jetting was observed in E1-P at depths of approximately 127 to 129 feet (Fig 3).

Figure 3: Water leaking (jetting) into E1-P on May 25<sup>th</sup> (note depth registration in this image is approximate, +/- 1 foot).

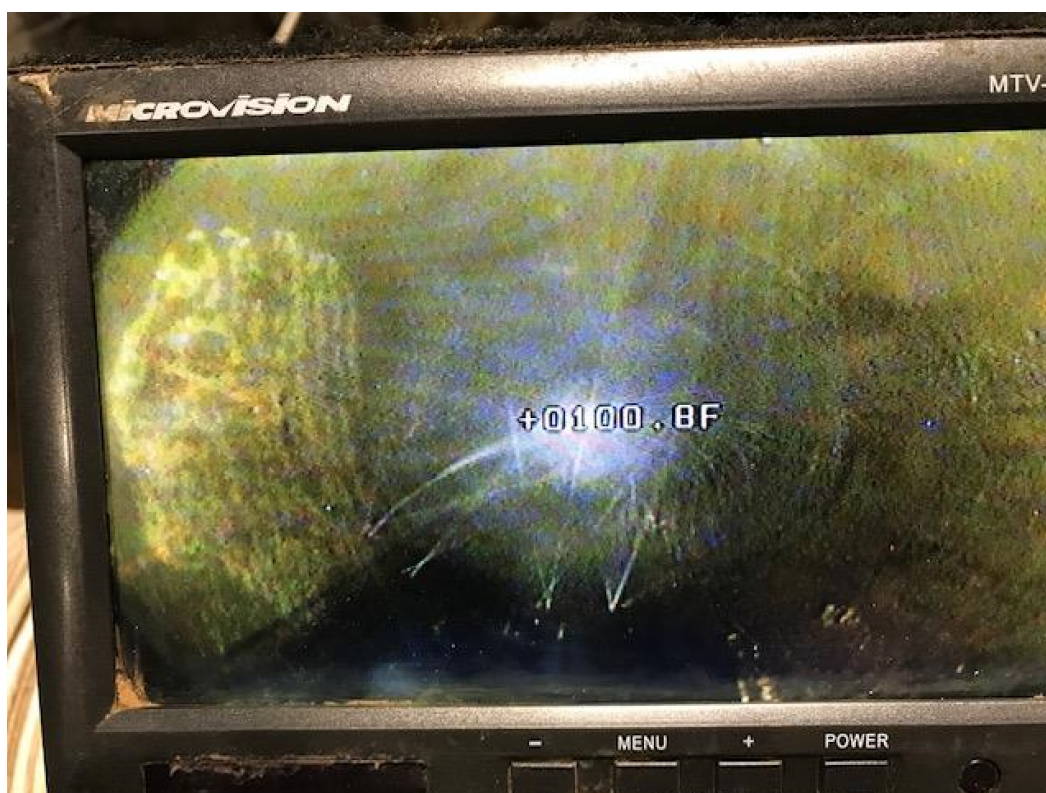
On Dec 21<sup>st</sup>, water was injected at the previously-stimulated (hydrofractured) depth of 142 feet in E1-I. The water was injected at increasing rates of up to 3.2 liters per minute into E1-I while searching for signs of flow into the E1-P. In monitoring the footage, E1-P was found distinctly flowing up to 1.1 liters per minute due to the injection into E1-I. There were 2 to 3 distinct locations of flow in E1-P with multiple jets at depths of approximately 100 to 102 feet.

Figure 4: Water leaking (jetting) into E1-P on December 21<sup>st</sup> (note depth registration in this image is approximate, +/- 1 foot).
