PEDIMENT GOLD LLC

# McGee Mtn. Project Geothermal Temperature Probe Activity

May 24 through May 30, 2010

A summary of geothermal probe activities during May 2010 at Geothermal Technical Partners McGee Mtn. Project, Nevada.

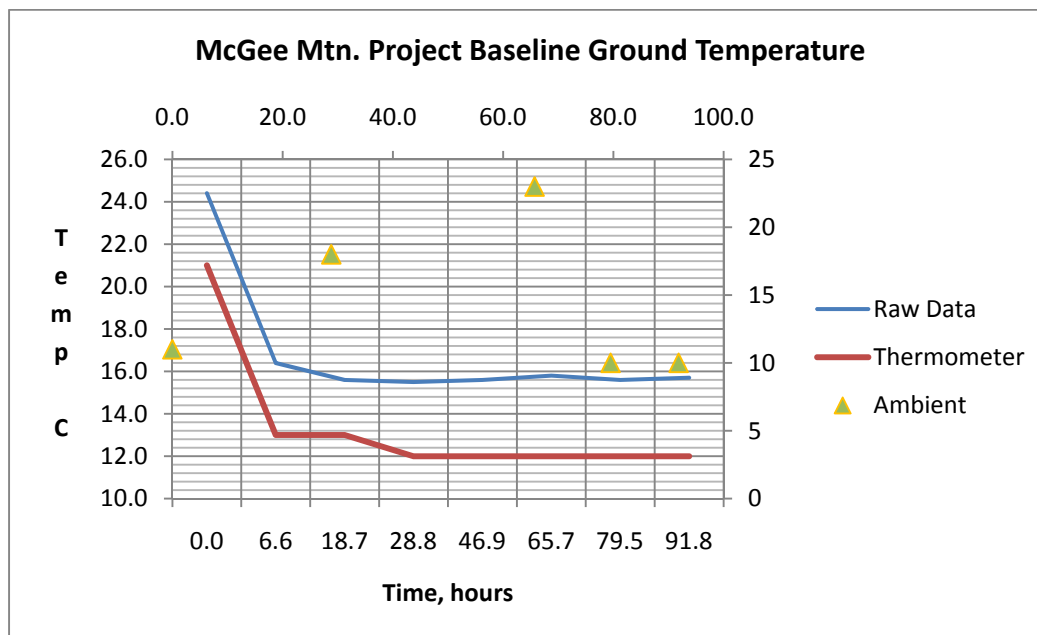
Figure 4: McGee Mtn. Project Baseline Ground Temperature collected at site MMTG#1.

The McGee Mtn. project baseline ground temperature was collected at site MMTG#1, (348,318E X 4,629,724N Datum: NAD27, Z11) was determined to be 12°C during the term of the project, see Figure 4. Two sensors were placed in the baseline hole: an RTD and a VWR thermometer. The thermometer had a probe with an epoxy tip sensor and a 3m (10ft) cable, to facilitate placing in the hole simultaneously taped to the RTD.

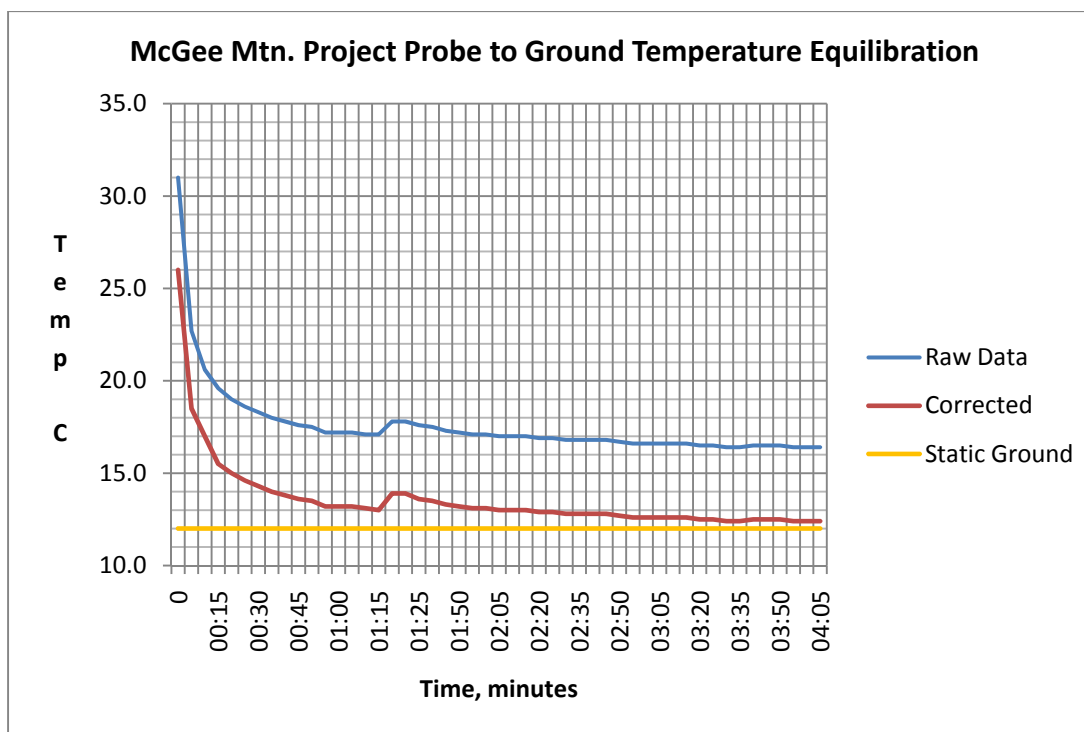
Figure 5: McGee Mtn. Project Ground to Probe Equilibration plot of cooling time.

The McGee Mtn. project probe to ground temperature equilibration took approximately 2 hours to equilibrate to 13°C, the upper error limit of the thermometer derived static ground temperature of 12°C (+/- 1°C) and four hours to assume 12.4°C, for a fifteen minute plateau, see Figure 5. The inflection at 1hr 15mins is the result of the sensor being pushed from approximately 16 inches above the disposable point (in "air") for the first hour and a quarter, onto and in direct contact with the disposable point.

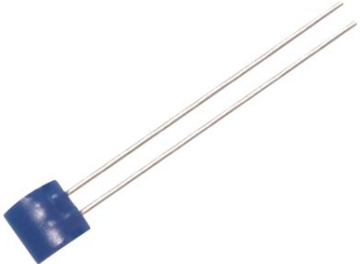
<p><b>1PT100G RTD Elements</b></p>
<p><b>RTD Surface Elements:</b></p> <p>A surface element is a special type of RTD element. It is designed to be as thin as possible thus providing good contact for temperature measurement of flat surfaces.</p>

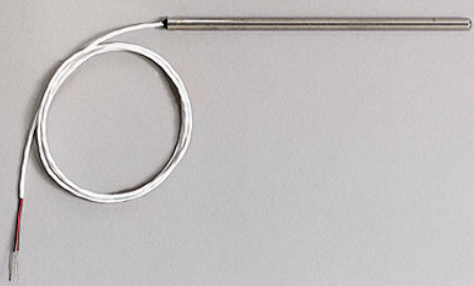
<p><b>RTD Probes:</b></p> <p>The RTD probe is the most rugged form of RTD. A probe consists of an RTD element mounted inside a metal tube, also known as a sheath. The sheath protects the element from the environment. OMEGA offers a wide variety of probes in various configurations.</p>

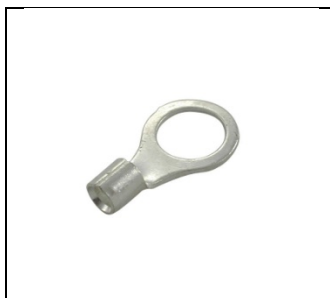
**Figure 8: Caltronics un-insulated Ring Terminal 26-24 wire size, #0 stud size (RT-90)**

Figure 8 is a ring terminal use to connect the 3 strand 18 guage bell wire to the TFD. The bell wire was looped through the ring and soldered in place (one single and one double). The TFD leads were then placed in the barrel connectors and crimped. The whole thing was then potted and covered with several layers of heat shrink tubing.

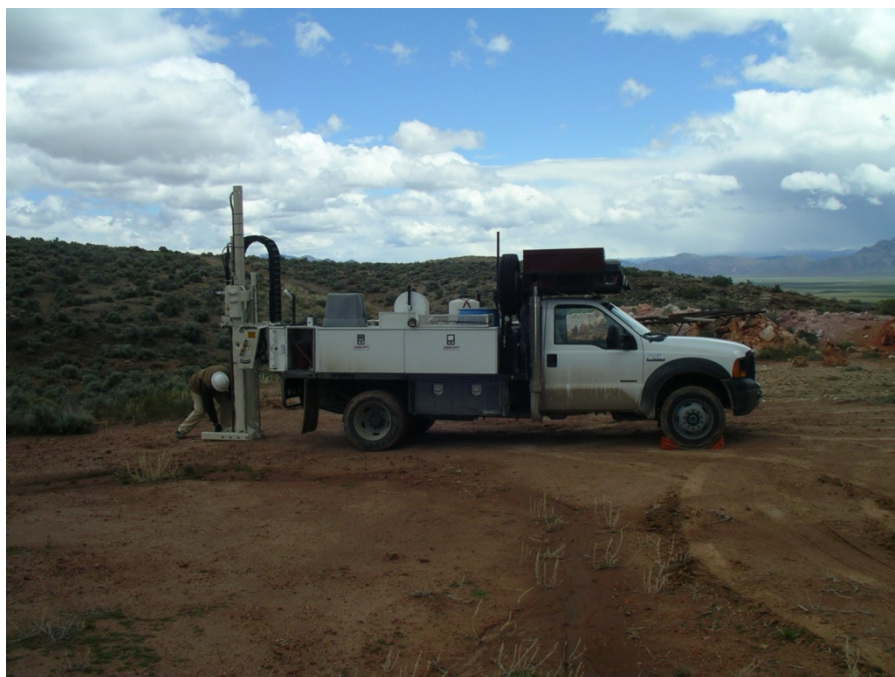
**Figure 10: Geoprobe in typical probing configuration**

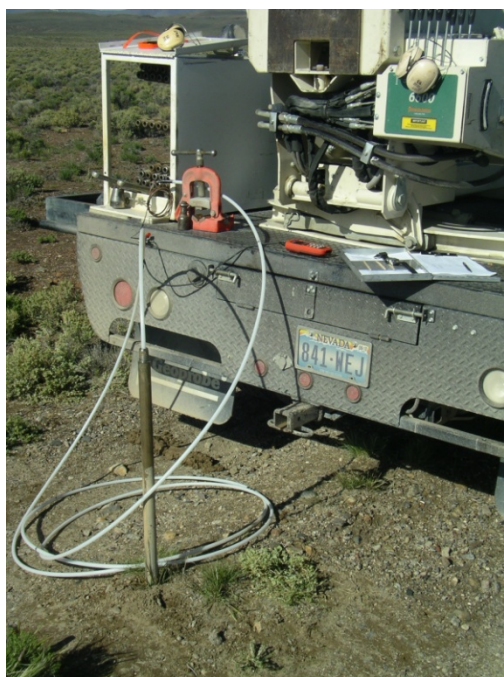
**Figure 11: The equilibration test at site MMTG#1: The probe rods were at depth, the RTD Installed and temperature recorded over time.**

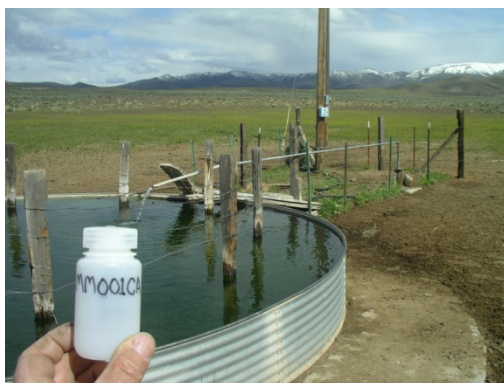
**Figure 12:** Water sample MM001 was taken from the Gillotti Well. The stock well was a 220V submersible pump that was running on arrival.

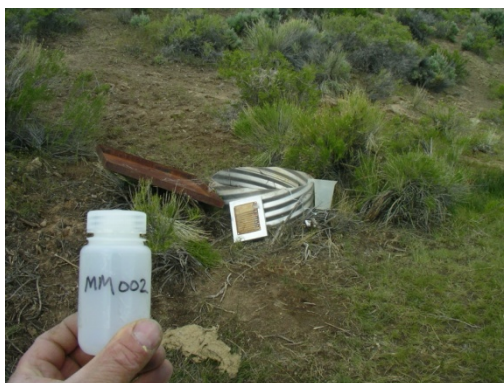
**Figure 13:** Water sample MM002 was collected from a developed spring. The water sample was taken from the spring box collection culvert using a rope to lower the sample pitcher some 10ft below the surface.

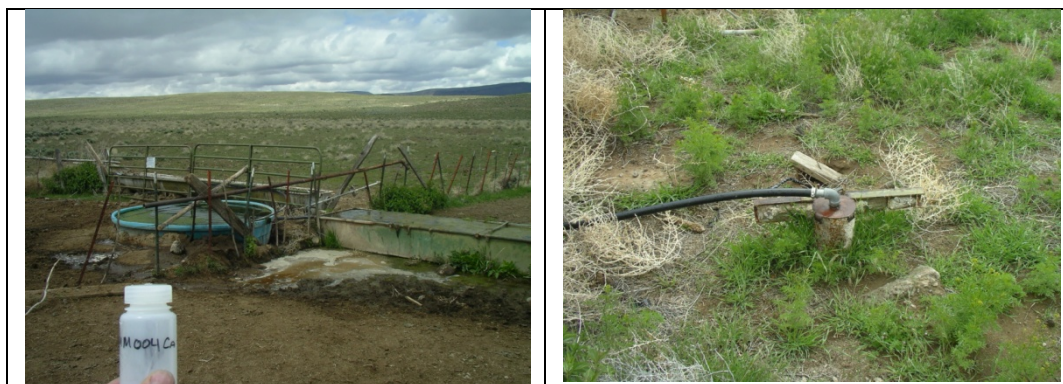
**Figure 14:** Water sample MM004 was a stock well being pumped by a 220V submersible that was running on arrival as seen in the photo to the left. Note the white ( $\text{CaCO}_3$ ) precipitate on the tank. The photo on the right is the wellhead. Damage to the environmental seal around the wellhead was noted and may be the source of nitrogen noted in the sample, as the adjacent pasture may have funneled cow manure during wet periods.

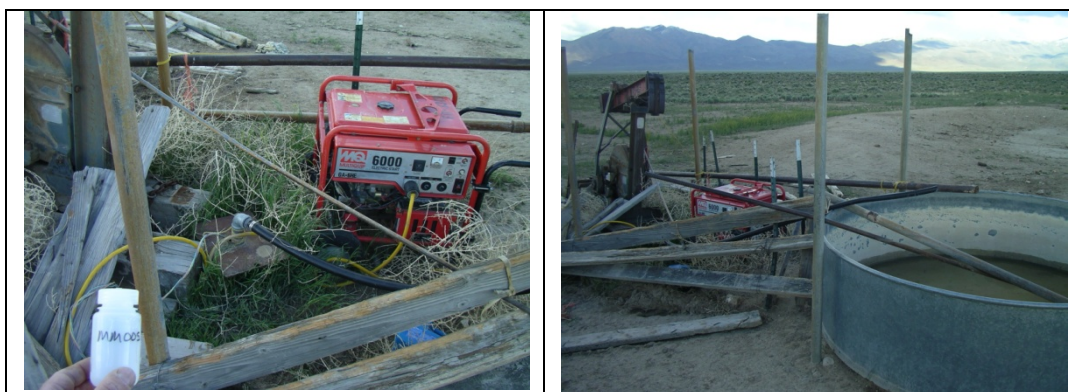
**Figure 15:** Water sample MM005 is a stock well that was not running on arrival. The generator was turned on, after adding gasoline, to run the well prior to sampling. The photo to the left is the wellhead and the photo on the right is the stock tank. Note the white ( $\text{CaCO}_3$ ) precipitate on the tank.

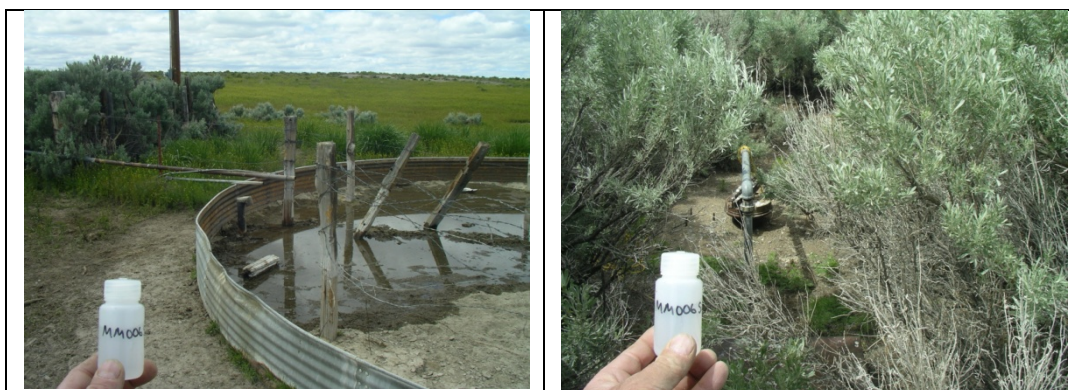
**Figure 16:** Water sample MM006 was taken at Bog Hot Valley Well. The 220V submersible pump was not running on arrival. The pump was turned on by flipping on the 220V breaker switch located on the pole and run for a period of time prior to sampling. The wellhead is in the photo to the right.

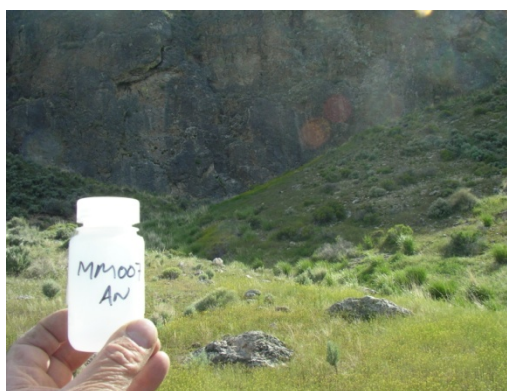
**Figure 17:** Water sample MM007 is McGee Mtn. Spring. The developed spring box, a vertical culvert, is located just at the base of the cliff to the right of the upper right corner of the sample bottle.

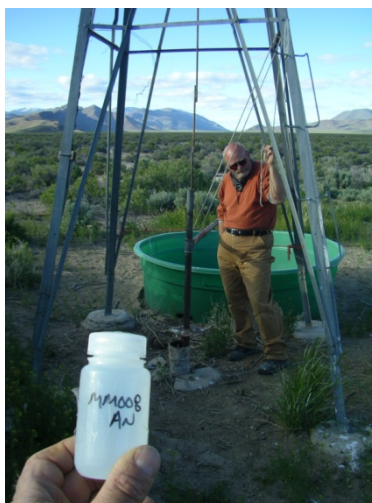
**Figure 18:** Water sample MM008 was taken from a non-functioning windmill. Mike Schramm is holding a makeshift block and tackle (minus the block) that we used to hold the top of the well in a position to get a bailer down the well. The windmill's pump rod is broken just above the top of the picture, just under the vanes. A large raven's nest with fledglings attest that it's been broken for a number of years.

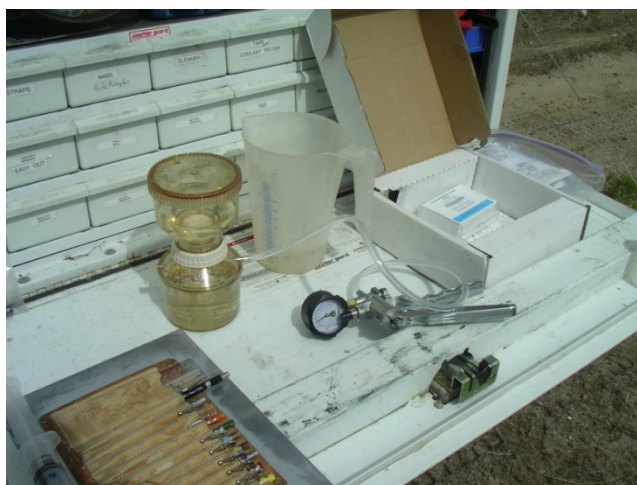
**Figure 19:** All water samples were filtered using the NALGENE Filter Holder with Receiver (Cat. No. 300-4050) and a Mighty Vac vacuum pump.
