GEOTHERMAL ENVIRONMENTAL EXPOSURE TESTING OF ENCAPSULANT AND DEVICE MATERIALS FOR HARSH ENVIRONMENT MEMS SENSORS

S. Wodin-Schwartz¹, J.C. Cheng¹, D.G. Senesky¹, J.E. Hammer², A.P. Pisano¹ ¹University of California at Berkeley, Berkeley, California, USA ²University of Hawaii at Manoa, Honolulu, Hawaii, USA

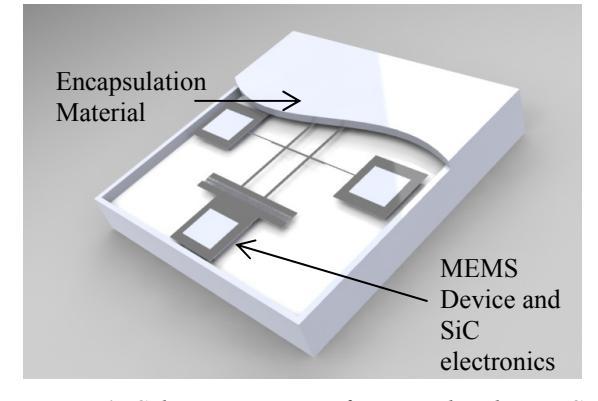
Figure 1: Schematic image of encapsulated MEMS sensor. Harsh environment encapsulation protects MEMS sensors from corrosion and oxidation in geothermal wells.

In addition to the high temperature and pressure of the harsh geothermal brine environment, low pH rapidly leads to sensor degradation and thus poor sensor reliability. For this initial set of tests, water, rather than brine, is used for sensor exposure to establish a baseline. Robust sensor packaging, Figure 1, is required to facilitate

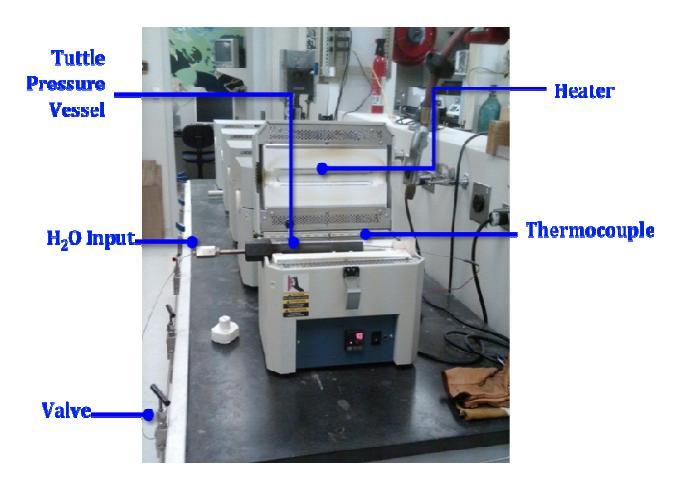
Figure 3: Tuttle-type pressure vessel used to simulate geothermal well conditions for exposure testing.

A simulated geothermal environment was achieved using a Tuttle-type pressure vessel, Figure 3. This vessel has an inner diameter of $\frac{1}{4}$ " (6.35 mm) allowing for the exposure of 5mmx5mm dies. The vessel is closed using a conical sealing method and connected to a water pressure line. The pressure line pressure sets the pressure of the fluid within the vessel at a given temperature. The temperature controller thermocouple is recessed into the vessel at the closed end. This allows for monitoring of the temperature closer to the samples precise location within the test setup. The pressure vessel is made of waspaloy, a Ni rich metal, which results in the intrusion of Ni from the vessel walls into the water. As most geothermal wells are cased with steel, the Ni contamination could be common in geothermal wells. This contamination allowed for the depth analysis of Ni intrusion into the material layers.

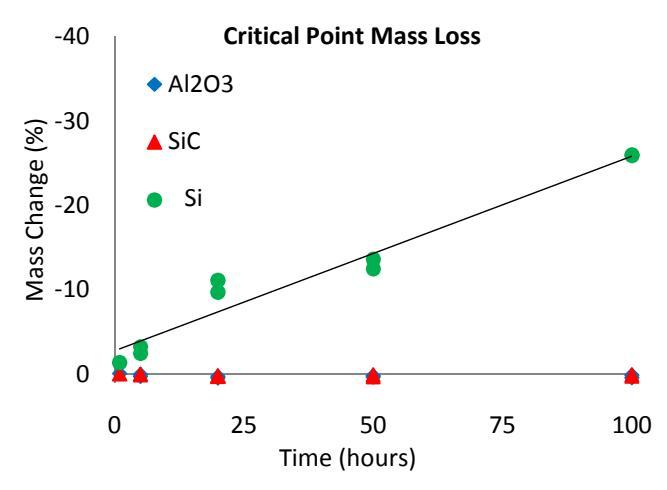
Figure 4: Mass change of silicon carbide, sapphire, and Si based samples for 1 to 100 hours of testing.

The mass was measured before and after the exposure test to examine any macroscale changes in the materials. As the mass of the AIN is within the tolerance of the scale, the SiC data points should show similar mass loss results for those samples. The silicon control samples experience a mass loss of over 20% over 100 hours of exposure as shown in Figure 4. The mass of the AIN and Pt was subtracted from the initial masses as the Pt delaminated as the AIN eroded in the vessel. This is a linear mass loss trend which indicates that there is a constant etching and removal of Si from the sample surface. It is most likely that the Si is being oxidized by the free ions seen in water at its critical point. This oxide then requires less energy to be removed from the sample surface into the surrounding water.

There was no detectable mass change of the SiC or sapphire samples over the 100 hours of exposure. This indicates that either there is very little damage done to these samples or that the damage did not cause a significant mass change as it may be causing a change to the material structure but not etching it away.

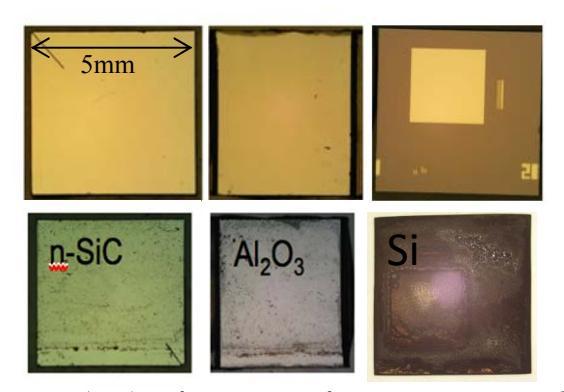
Figure 5: (Top) Before images of expose 5x5mm samples. (Bottom) Images of samples post 5 hours exposure in critical point water. Note: The sputtered Pt delaminated from the AlN layer on the Si sample during exposure.

The macroscale sample damage can be seen in Figure 5. Both the SiC and sapphire samples surfaces have some vessel residue on their surfaces. This residue was removed with an ethanol bath. The Si sample lost the Pt and AlN and the silicon also begins to corrode. This degradation is most visible in the upper right corner of the sample.

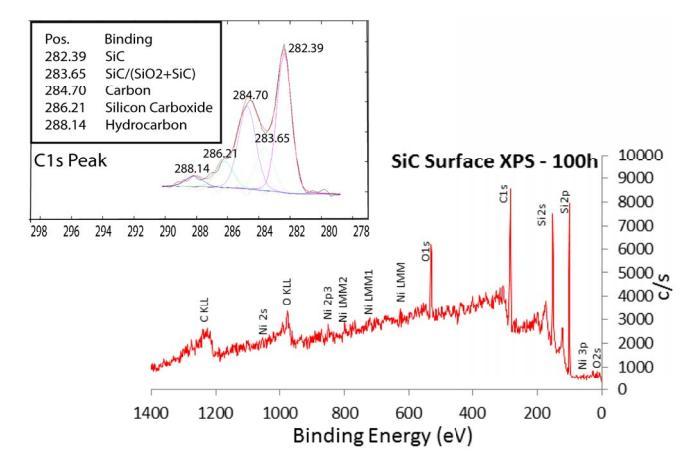
Figure 6: Surface XPS data of 100 hour exposed SiC sample. Analysis of the C1s carbon peak, upper left, revels that there is oxidation as well as the formation of hydrocarbon chains.

Sputter XPS analysis was conducted to determine the degradation of the SiC, sapphire and AlN over the exposure times. Surface scans of the SiC samples showed the expected Si, O₂ and Ni binding energies, however there was also a carbon peak. Looking at the specific carbon bonding showed carbon as it is known to be found with SiO₂, the formation of hydrocarbons and the diffusion of Ni, Figure 6. The exact chemistry of the hydrocarbon formation is now entirely clear, however, it is likely that the free ions in the critical point water caused local reactions with the SiC to form SiO₂ and C. Both the out diffusion of oxidation reaction products and product removal are hindered by the surrounding static water more than that of the traditional oxidation vapor stream. This would lead to the buildup of products within the sample. Thus, we do not see the clean SiO₂ layer as predicted by the theoretical modeling of the SiC oxidation process. These free carbon atoms are shown in the scan in elemental form, however they also achieved a more stable state in the form of larger molecule chains when bonding with free hydrogen ions. The silicon carboxide would also be formed in a similar way with the addition of some silicon atoms.

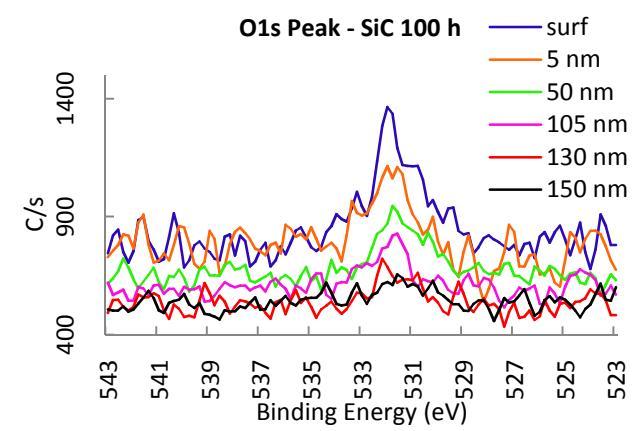
Figure 7: Depth of oxidation of SiC over 100 hours of testing based on XPS of the O1s peak. The peak is indistinguishable from the signal noise by 150 nm.

Once surface damage was detected, the depth of that damage was measured. While some material degradation is tolerable for an encapsulation or substrate material, that damage must be asymptotic to prevent total encapsulant failure. To determine the depth of sample degradation, the samples were sputtered in 5, 10 and/or 15 nm depth increments. The sputtering depth rate was calculated based on the sputtering rate of SiO₂. The hydrocarbons, elemental carbon, and silicon carboxide were only found on the surface, or first 10 nm, of the samples. However, the SiO₂, and the Ni contamination continued through the SiC sample. At each depth step, an XPS scan was taken. The strength of the Ni and SiO₂ signals decreased with depth into the sample. The oxide depth was determined to be reached when the signal was indistinguishable from the scan noise. Over the 100 hours, the oxidation behavior reached an average depth of approximately 150 nm from the surface of the SiC samples, as seen in the depth scans shown in Figure 7. The sample exposed for 50 hours only showed oxidation to 65 nm. This non-asymptotic behavior indicates that the SiC will continue to degrade with increased exposure time. Nickel ions were able to penetrate to a depth of 50 nm in the SiC after 100 hours of exposure. This was an increase of 15 nm from the 35 nm Ni penetration depth with the 50 hour exposed SiC sample.

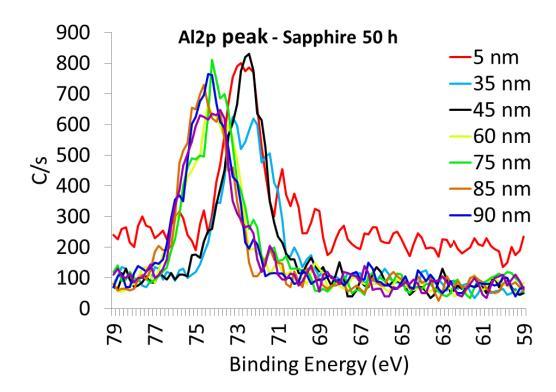
Figure 8: Shift in Al2p peak from a 50 hour sapphire sample. The first 50 nm of the sample are degraded and shown by a shift in the peak. All of the peaks have been shifted by 9 eV to account for sample charging.

The degradation of the sapphire structure was shown in a different way from that of SiC. As sapphire is already an oxide, the XPS scans were looking for binding energy shifts in the oxide peak. These shifts around the 74 eV binding energy for the $Al_{2}p$ peak indicate oxide degradation to a different binding from $Al_{2}O_{3}$ to other aluminum oxide forms. The binding energy shift can be seen in Figure 8. This damage by the infiltration of ions penetrated to a depth of 50 nm for both 50 and 100 hour exposure tests. The nickel diffused to a depth of 10 nm for both of these exposure times. This indicates that sapphire was the most stable encapsulation material for down-hole geothermal sensors.

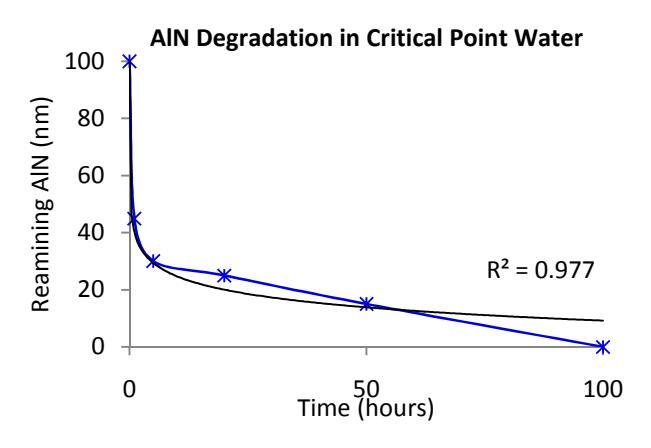
Figure 9: AlN thin film degradation over 100 hours of testing. An exponential decay trend line is shown with the experimental data.

While down-hole devices will be encapsulated during operation, it is useful to know the survivability of potential device layers in the event of partial encapsulation failure. The 100 nm AlN thin film layers that were exposed to the simulated geothermal environment did not survive for long exposure times. Over the 100 hours of exposure, the AlN layer showed an exponential decay in thickness, as would be expected with chemical etching, Figure 9.
