16B(78)-32 - 9.5in
BHAs #11 through #17

4: Directional BHA #4 HALO, 9 1/2" Hole section

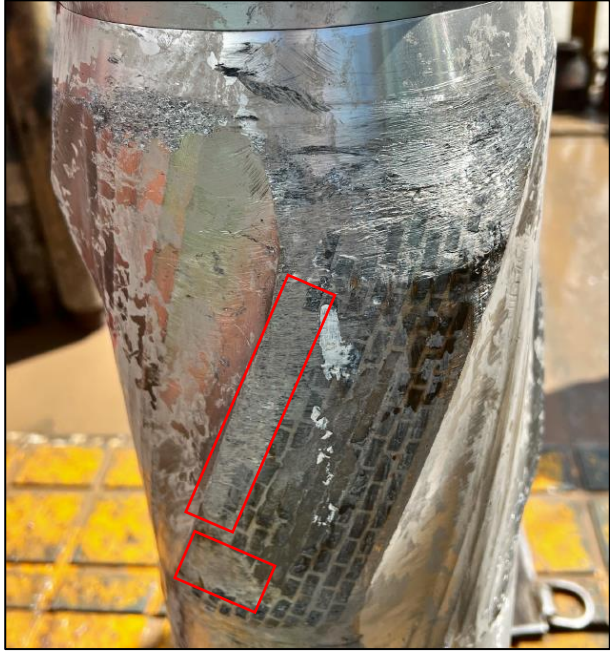
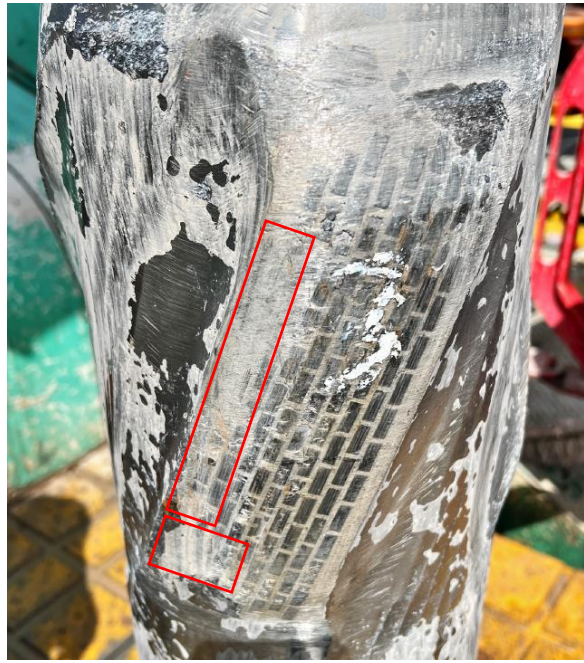
Leading Edge Wear

- Roller reamer roller element/button and stabilizer wear likely due to BHA whirl which was more severe while off bottom. Need to verify with NOV BB data.

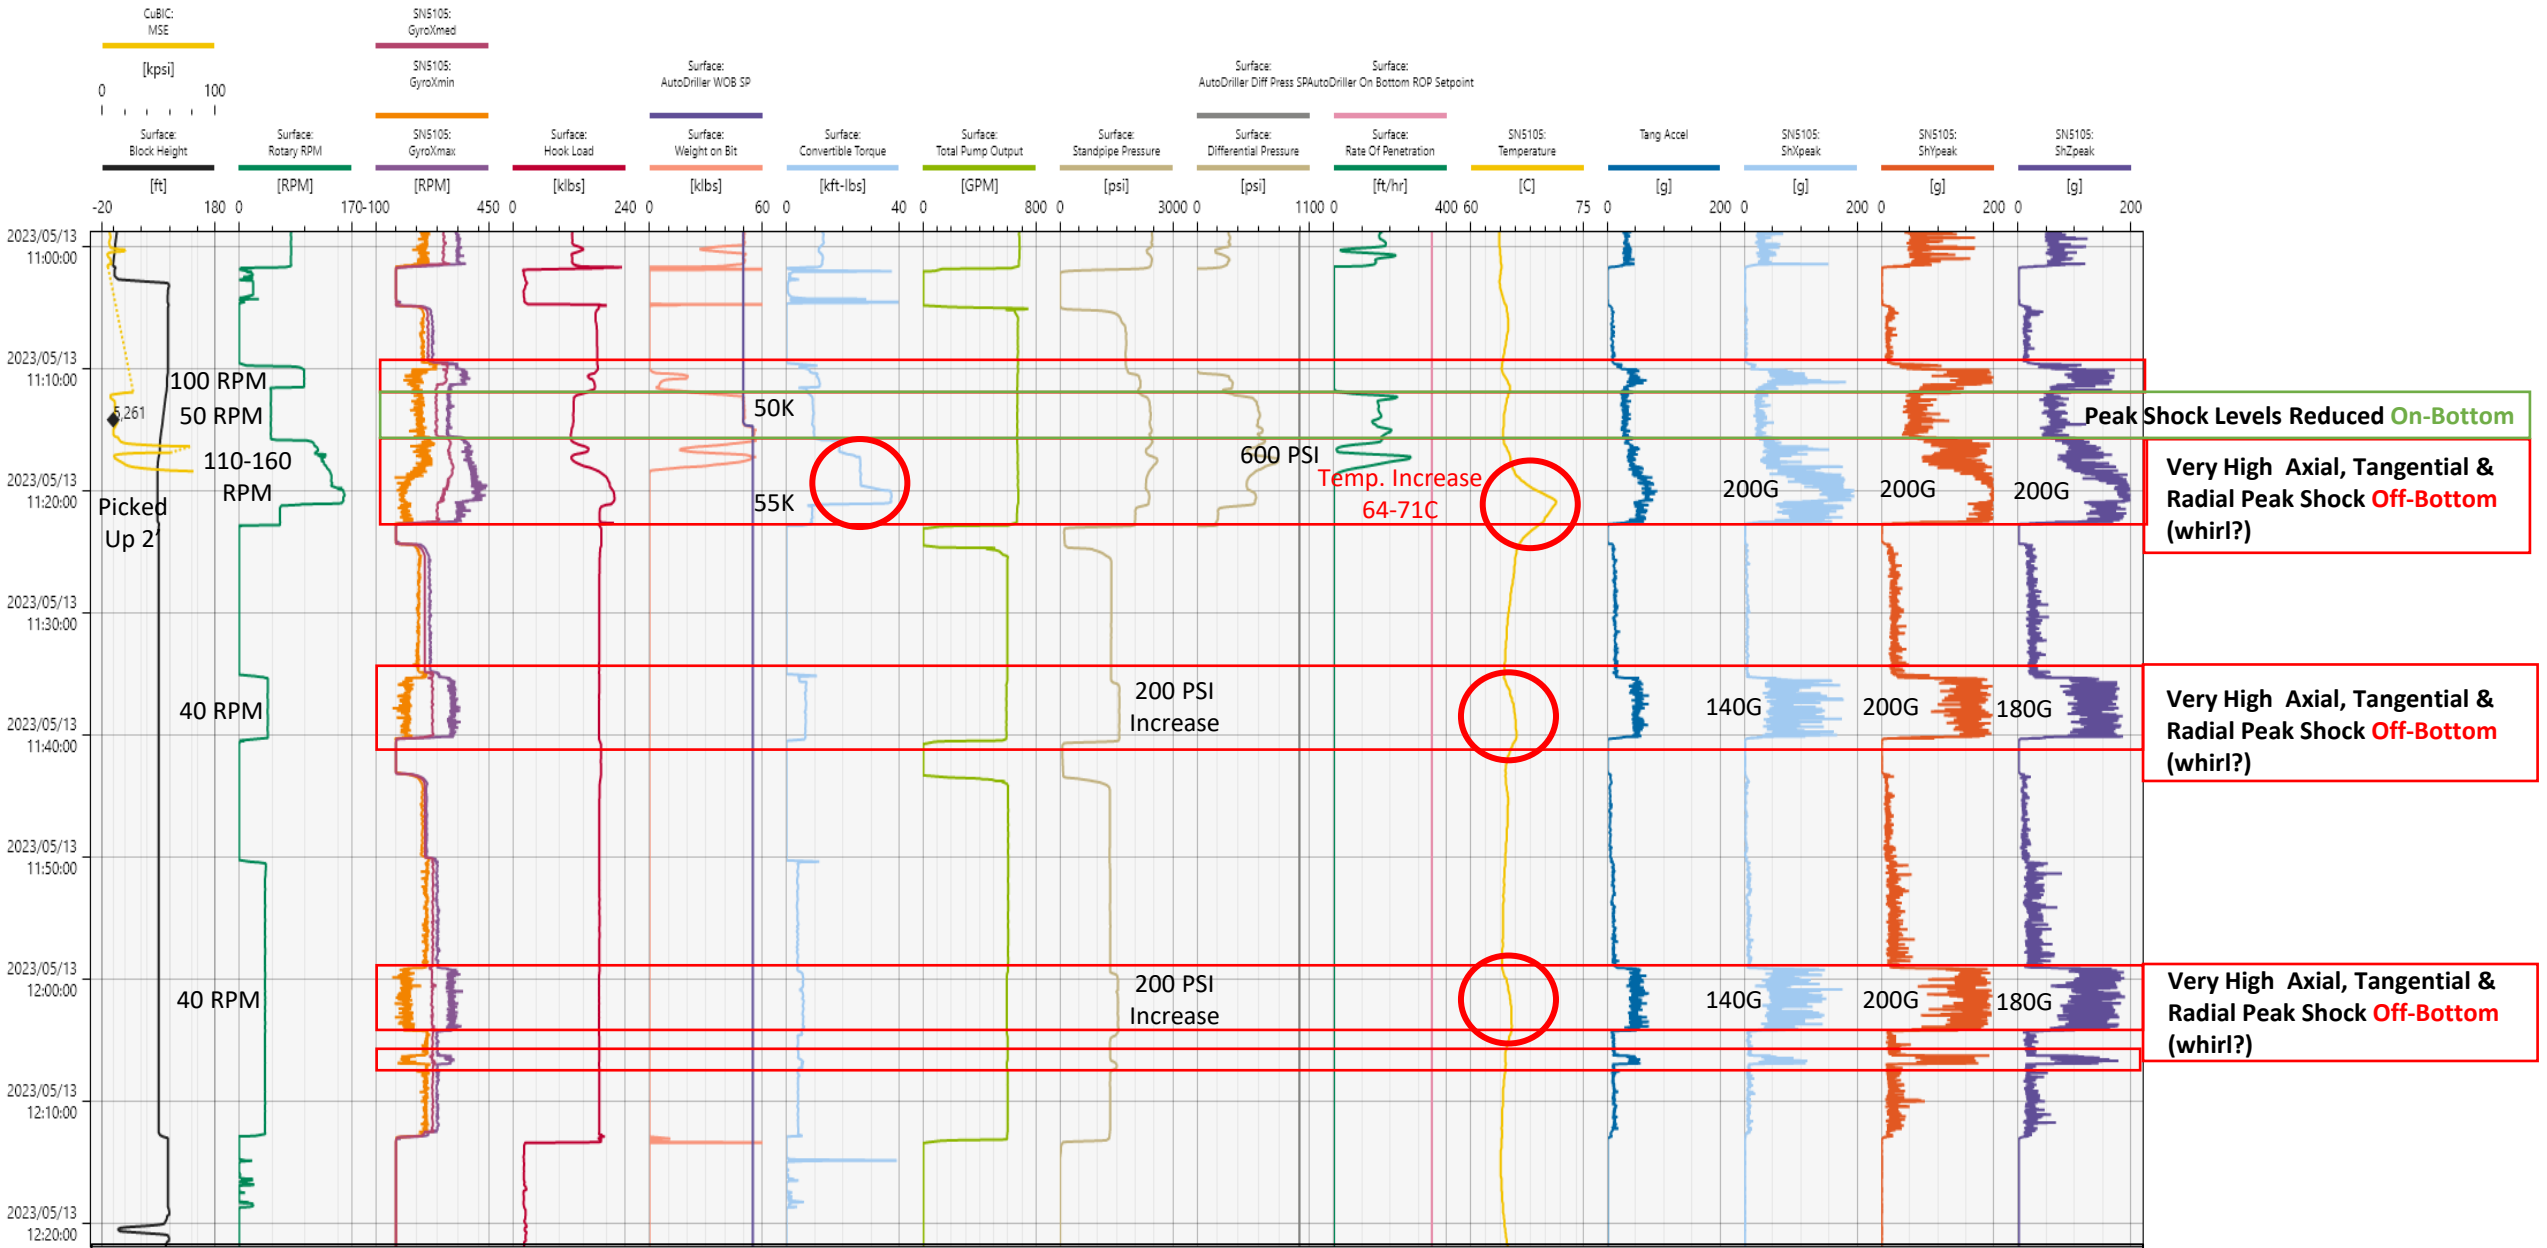
BHA #11 (4) – Stand Zoom

Of significant interest on this stand is increased 3-axis shocks when 1) Ramping up RPM /picking -up and partially off bottom (see next slide zoomed); 2) Picked up 2' off-bottom – Is this bit off bottom? Is this bit whirl? Is the whirl transferring to BHA? Need to validate with NOV BB data.

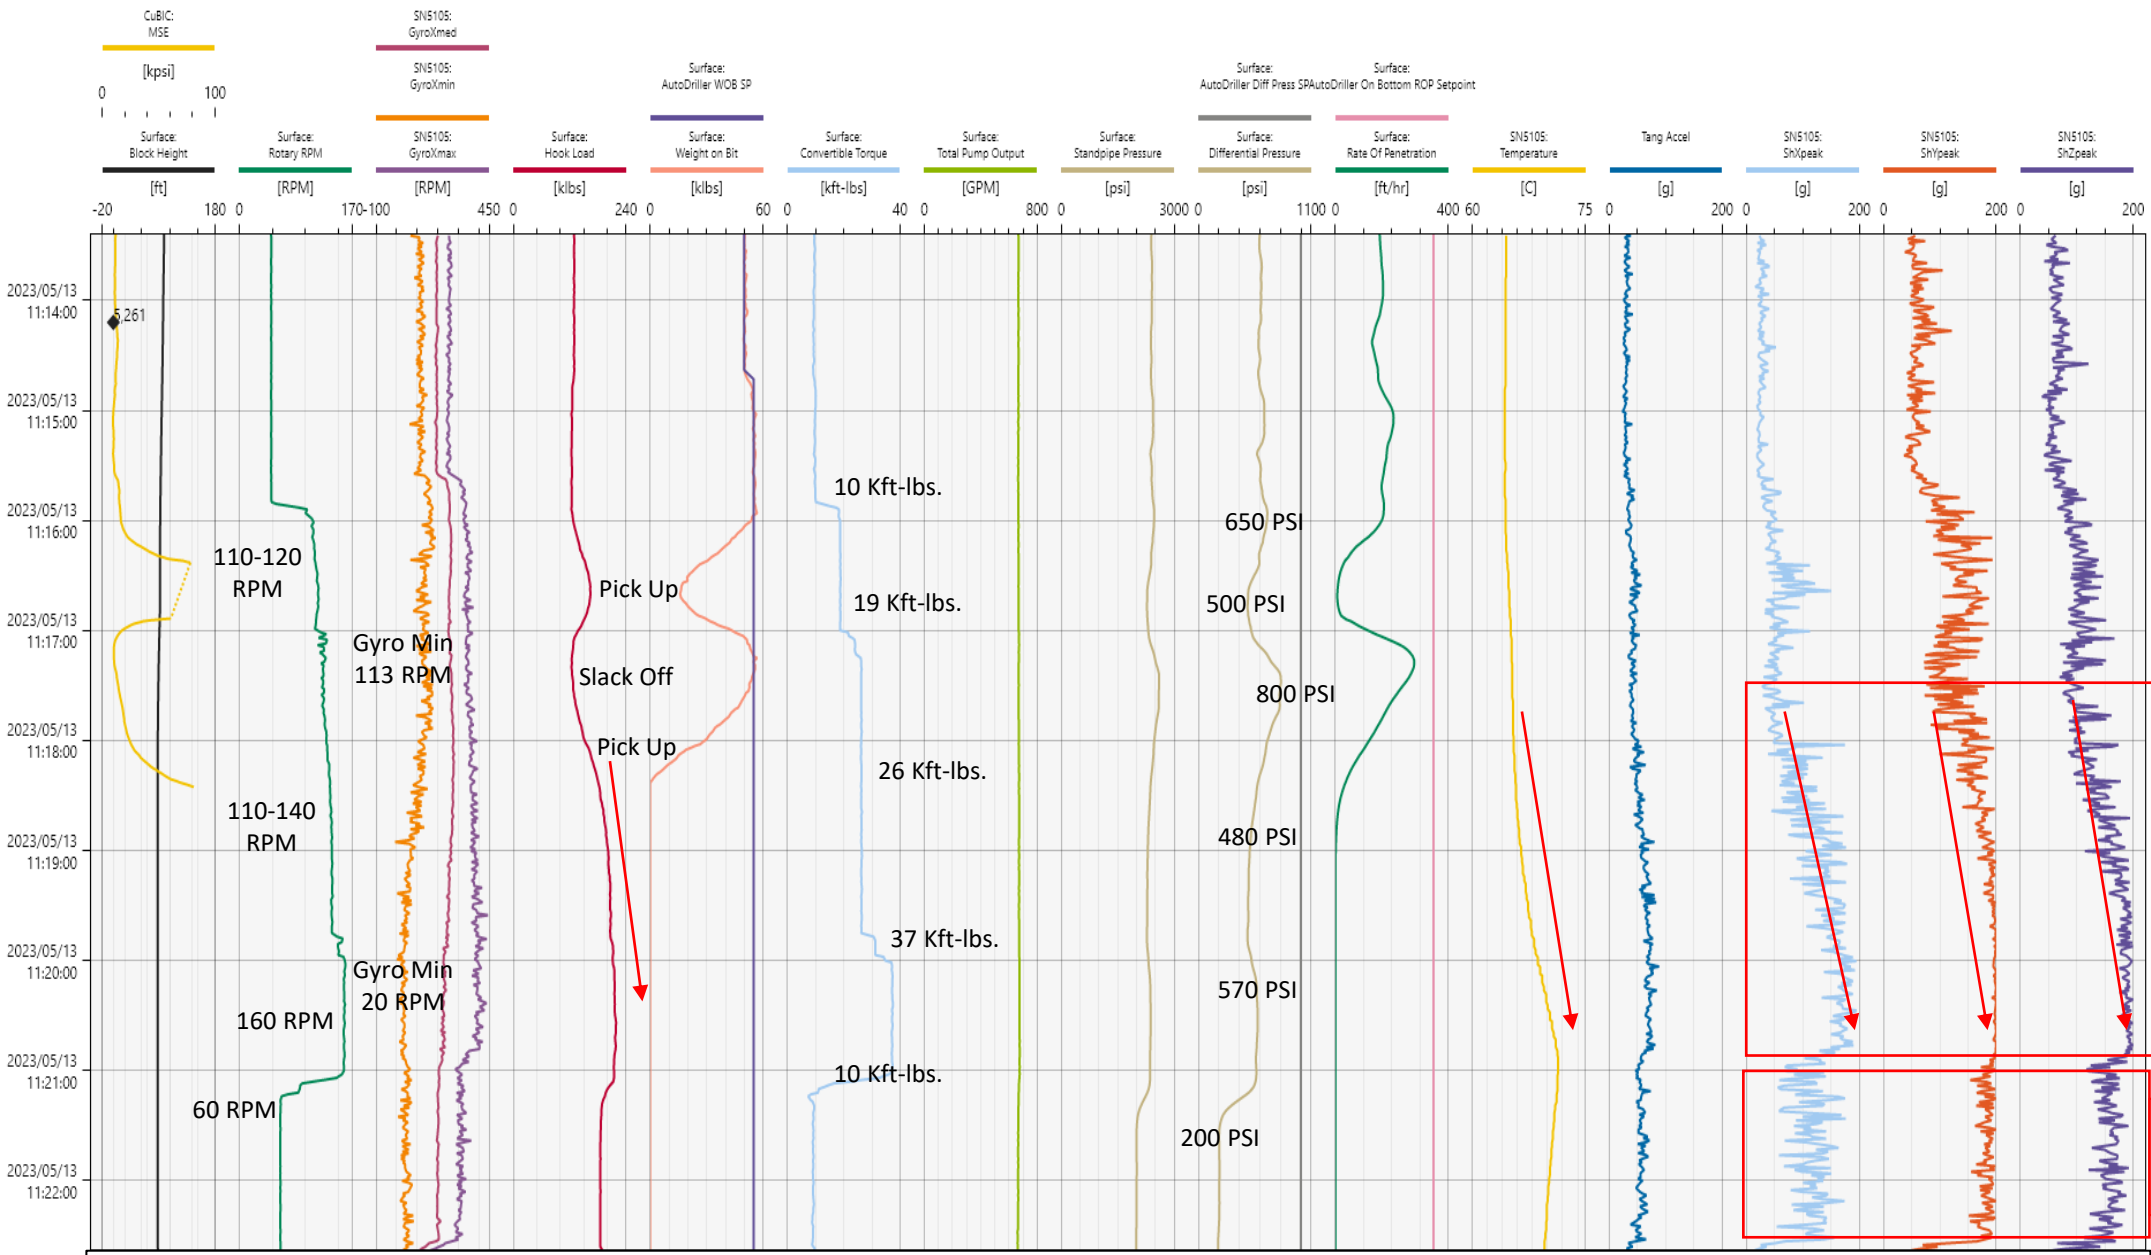
BHA #11 (4) – Stand Zoom

Axial, Tangential & Radial Peak Shocks progressively increasing to very high levels when picking up. Temperature increase is seen at same time.

Reduction in 3-axis peak shock correlates with reduction in surface RPM.

All 3-axis peak shocks increase when picking up and ramping up surface RPM. Temperature increase at same time. Motor continues to pull differential. Possible bit is not fully off-bottom in combination with bit whirl. Any indication of string whirl from NOV sensor sub?

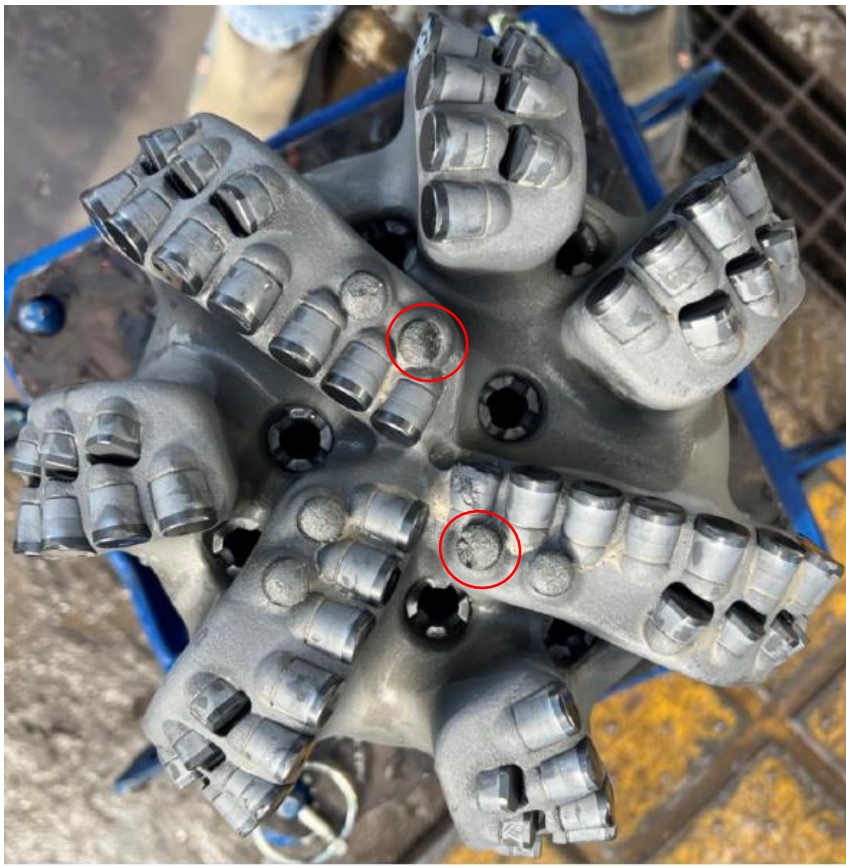
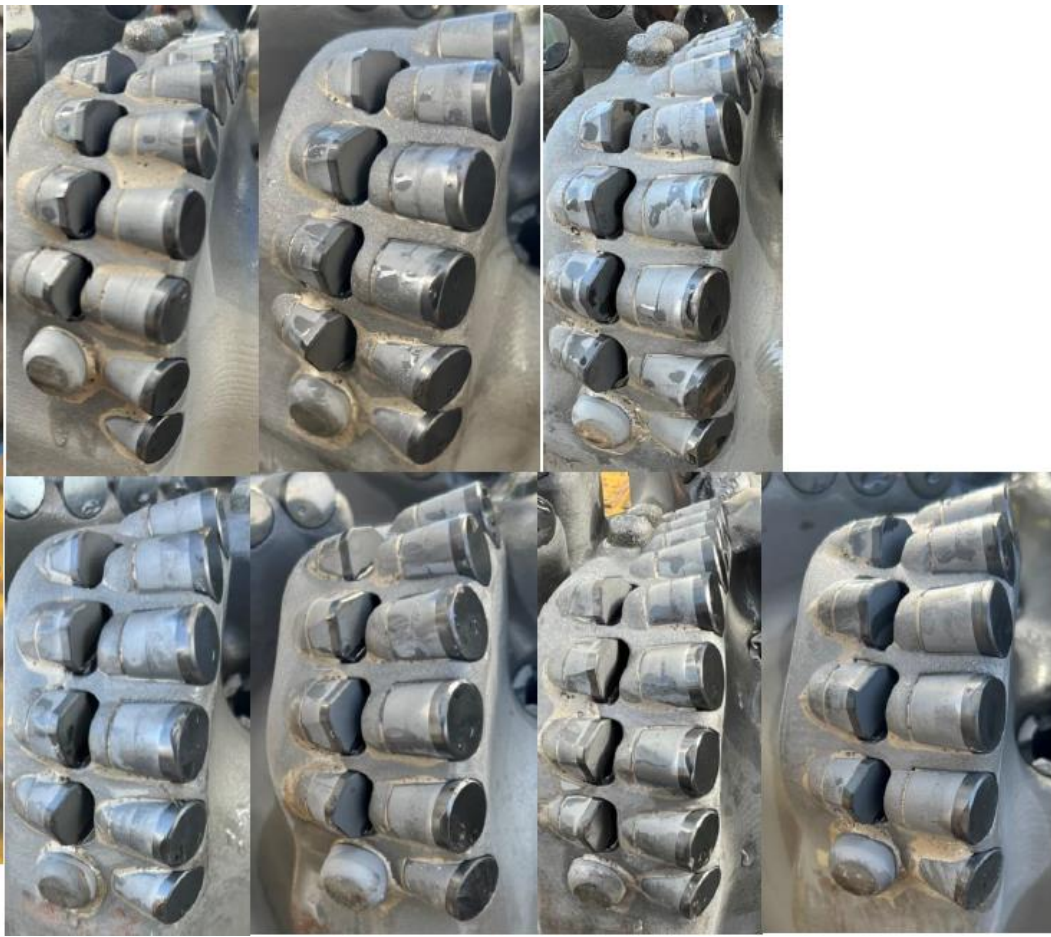
ROP Limiter: Drilled curve from 0 degrees to 20 degrees. BHA had a Halo RSS but no mud motor.

Solution: Figure out BHA vibration modeling to allow for mud motor to be ran.

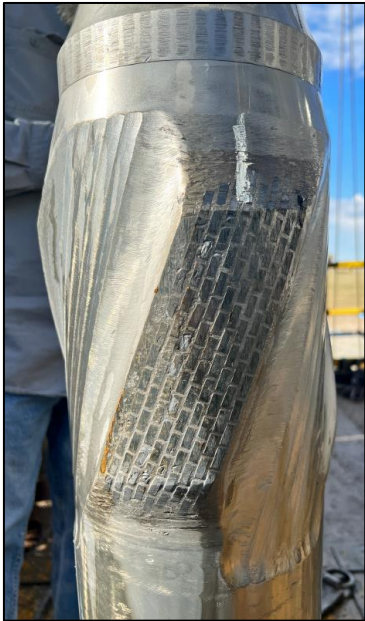
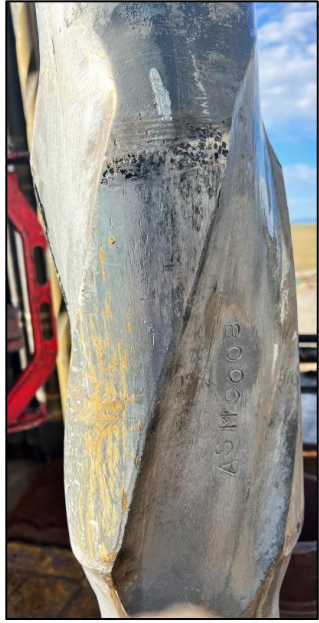
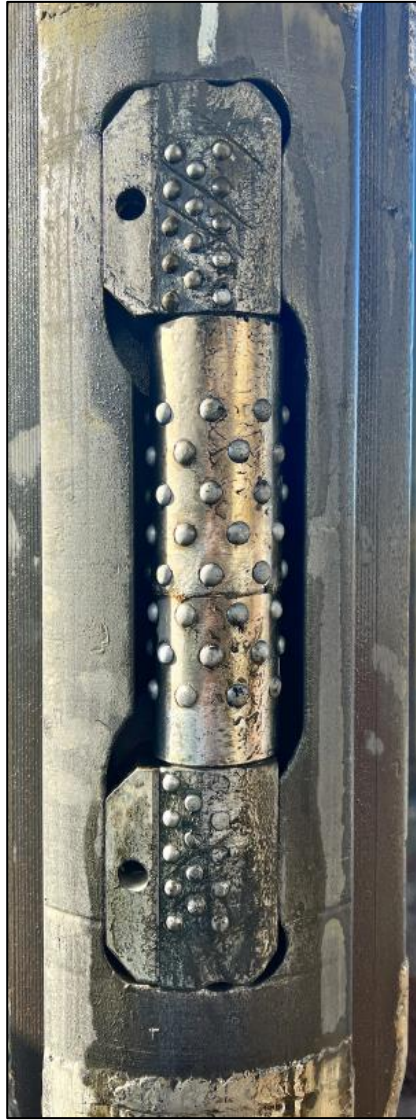
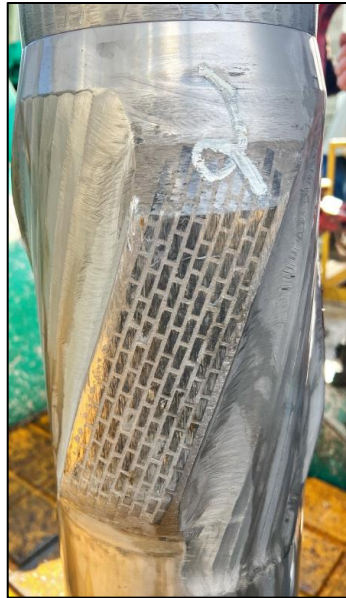
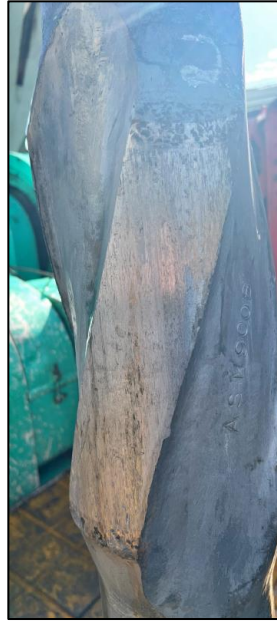
BHA #12 (5) HALO RSS NO MOTOR

Good condition.

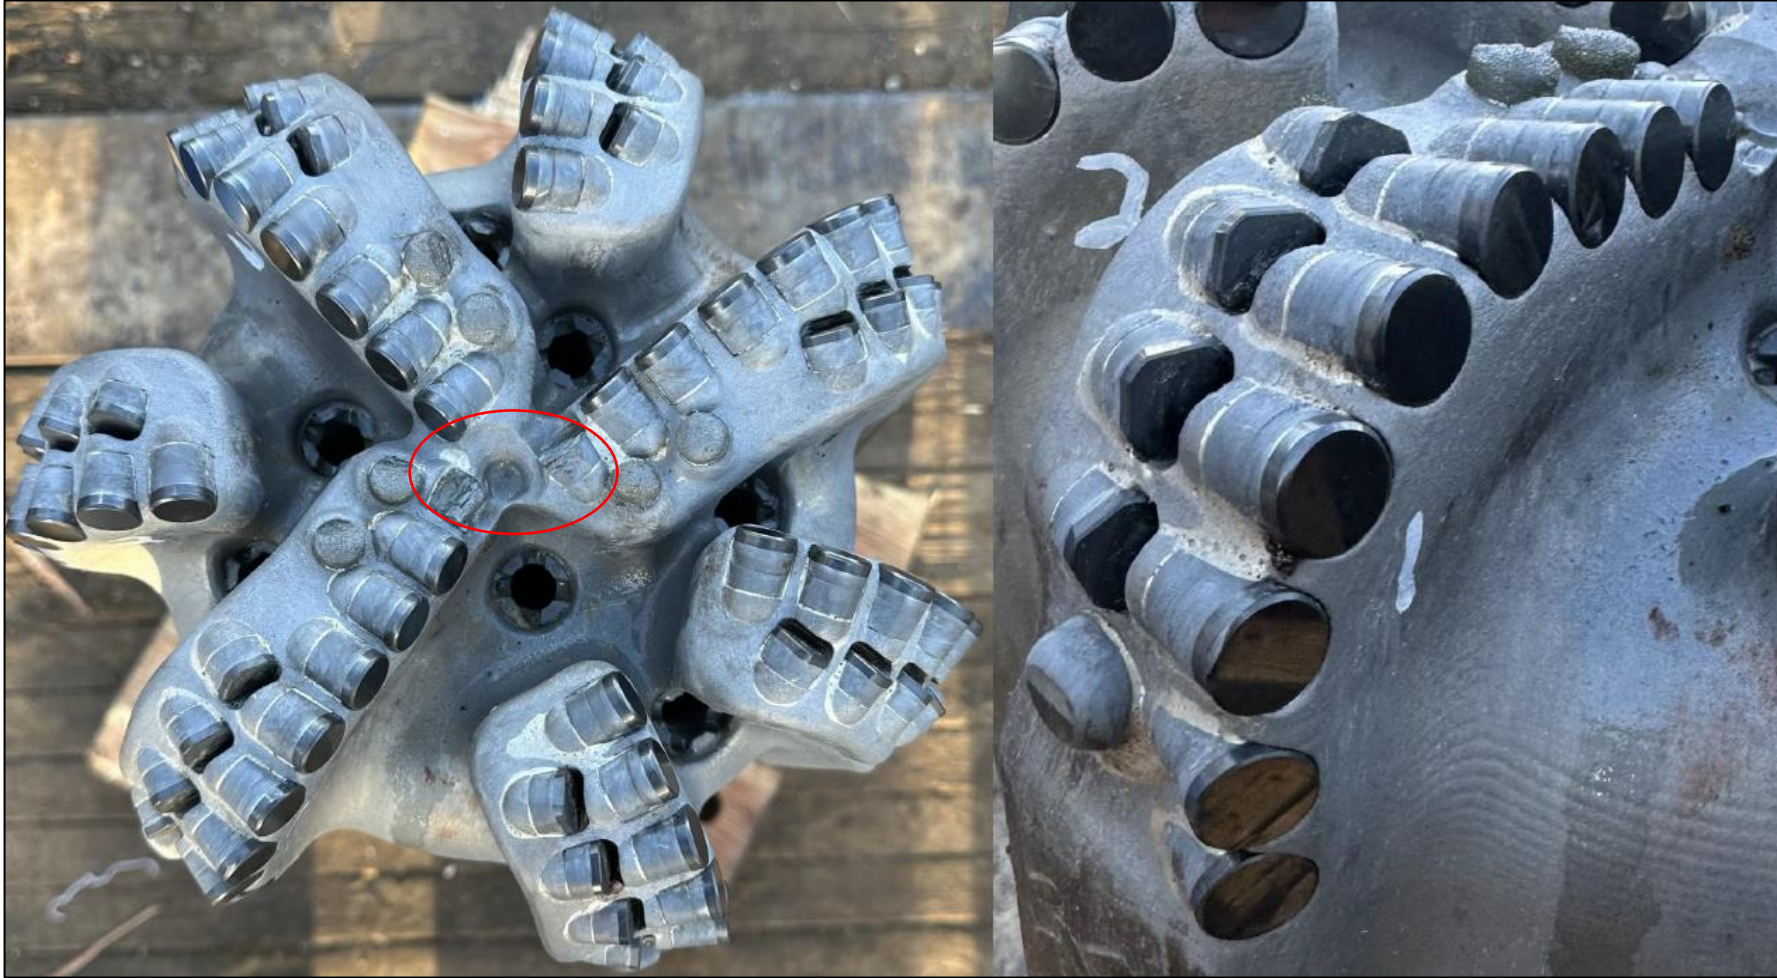
ROP Limiter: Drilled curve from 20 degrees to 40.3 degrees.

Small core out on the bit. This run was with an RSS but no motor in the hole.

Steel shot from Particle Drilling is still seen on the shakers at about 5% concentration.

Solution: Figure out BHA vibration modeling to allow for mud motor to be ran.

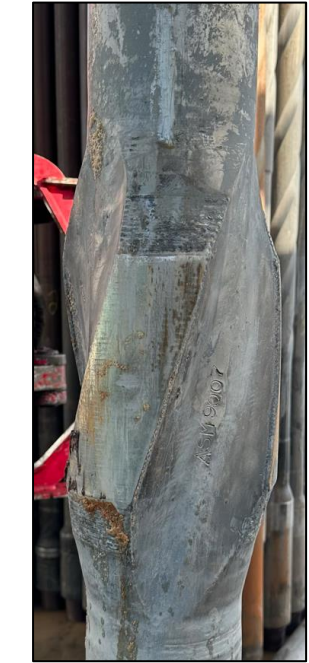
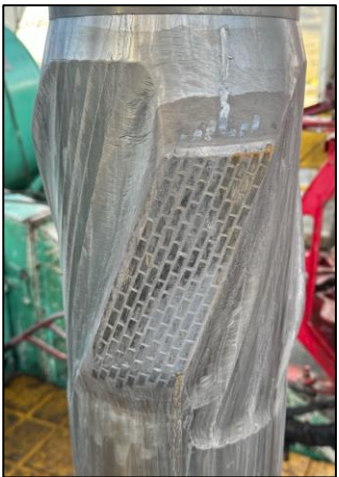
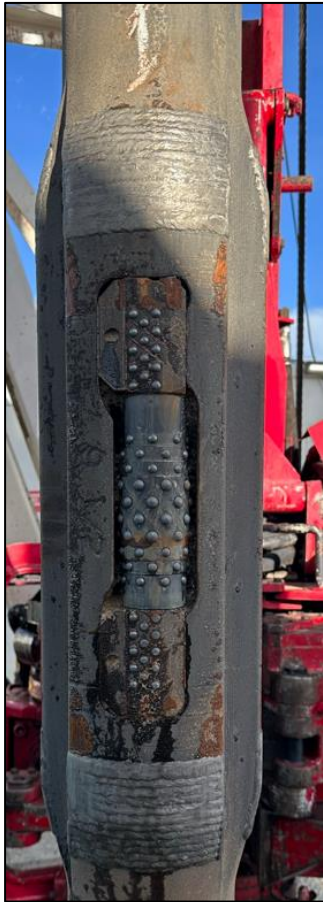
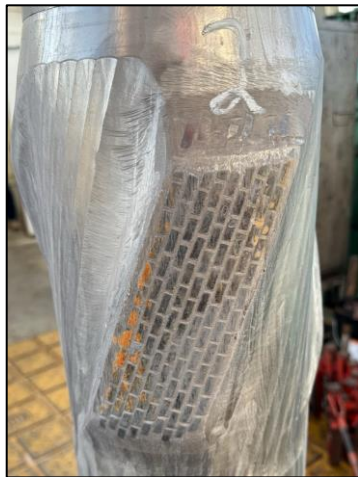
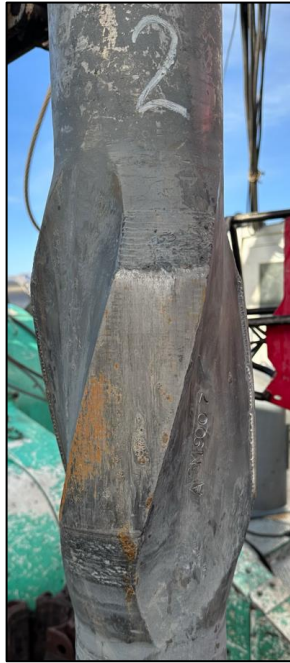
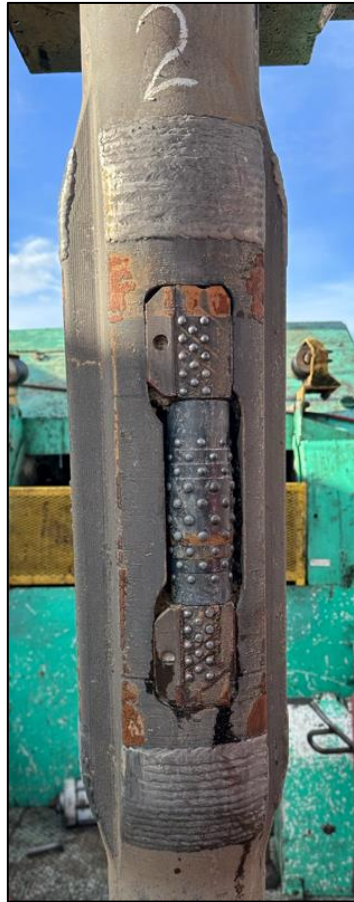
Good condition.

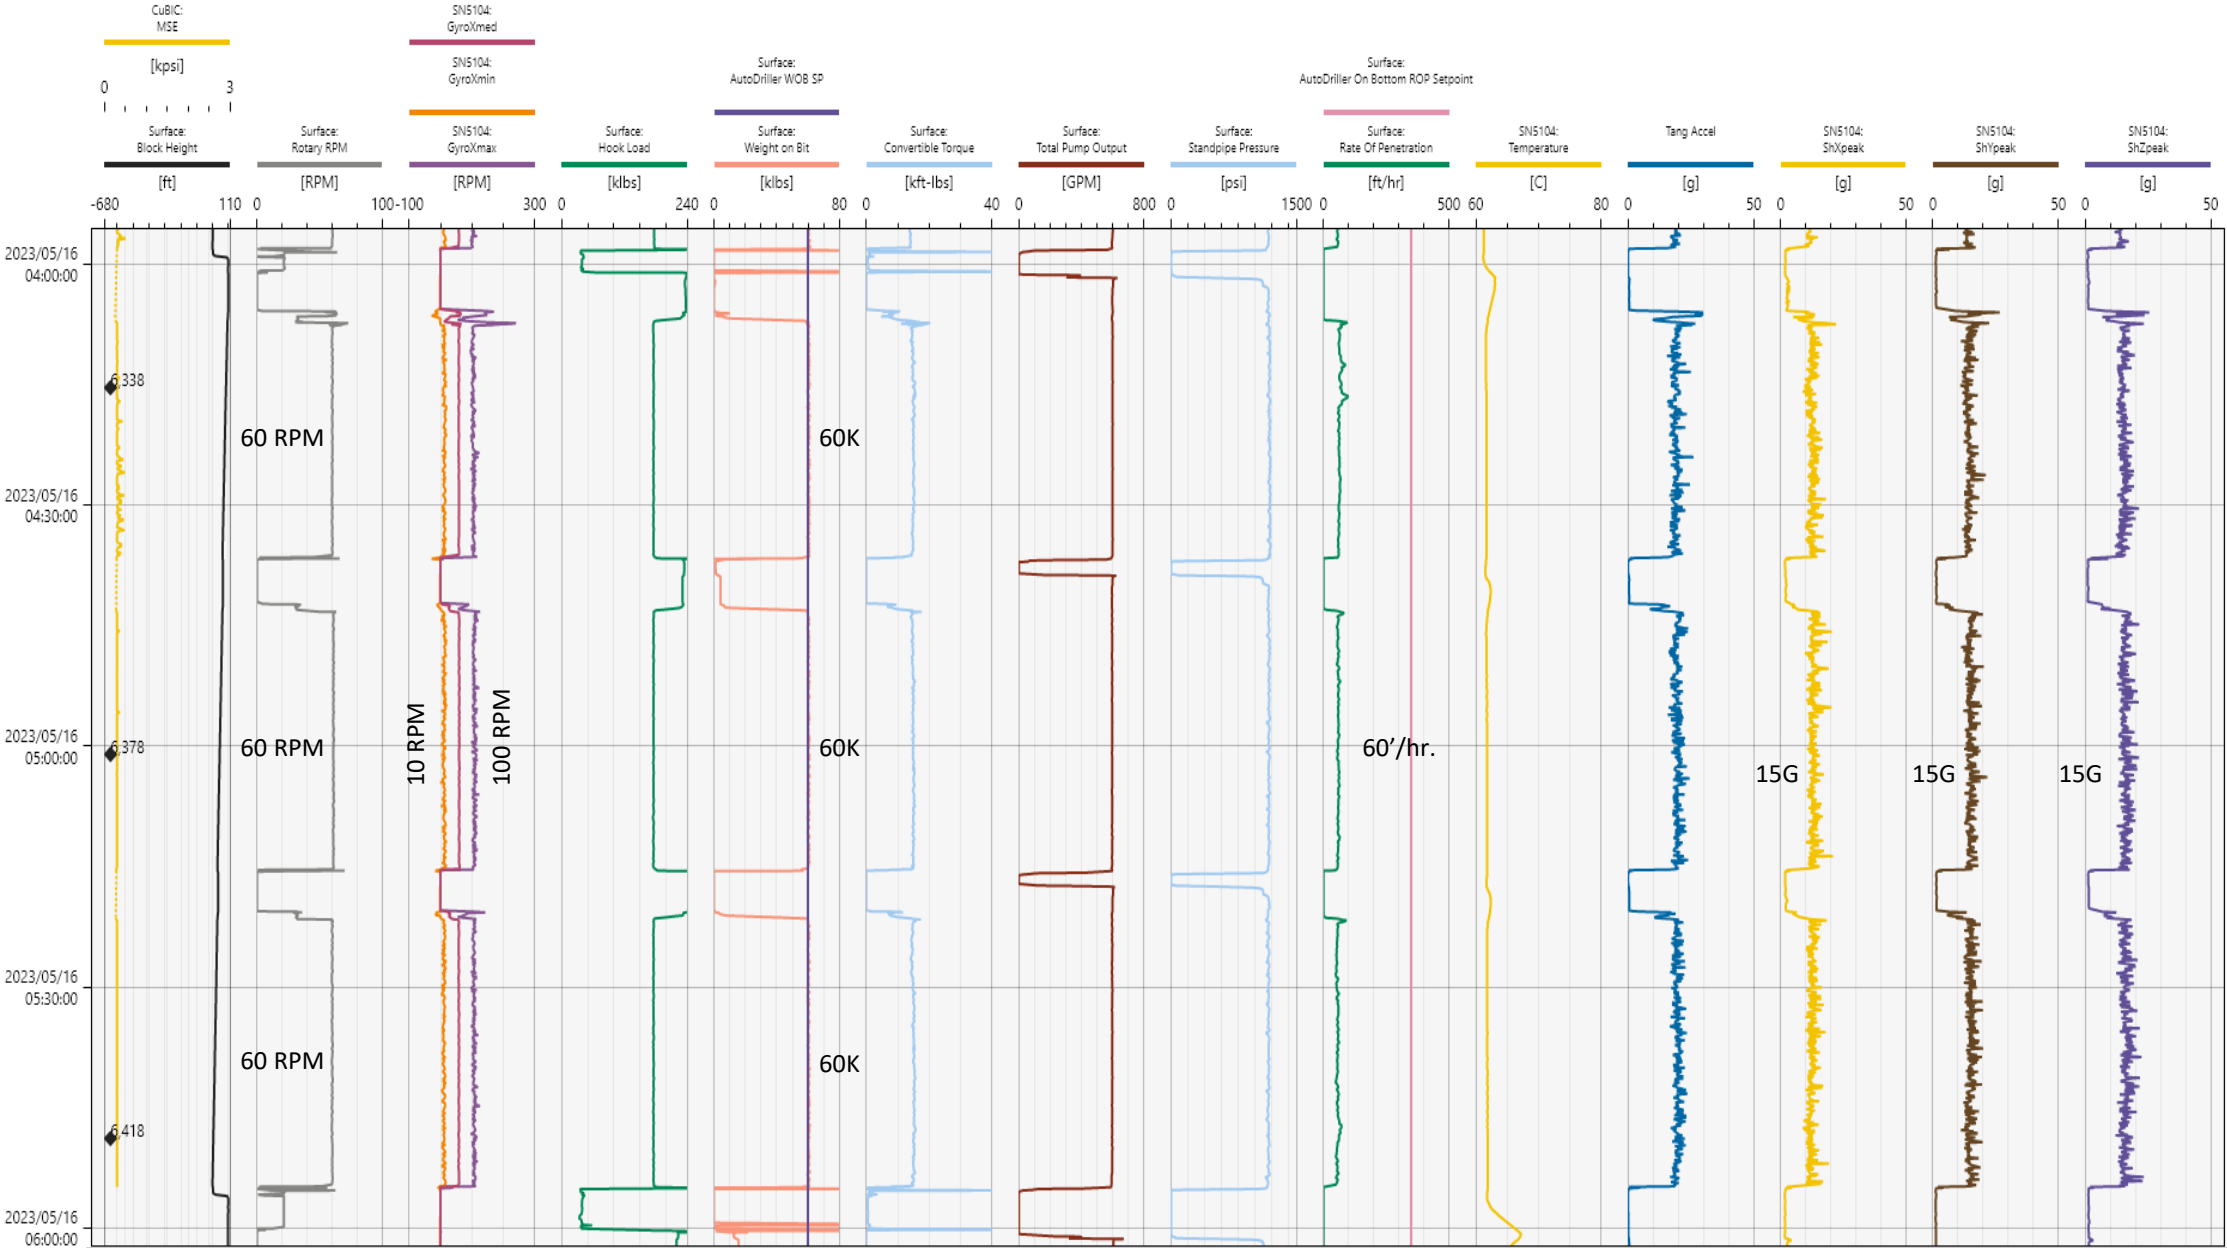
BHA #13 (6) – Stand Zoom

3-axis Peak Shock levels are low. ROP is steady at 55'/hr.

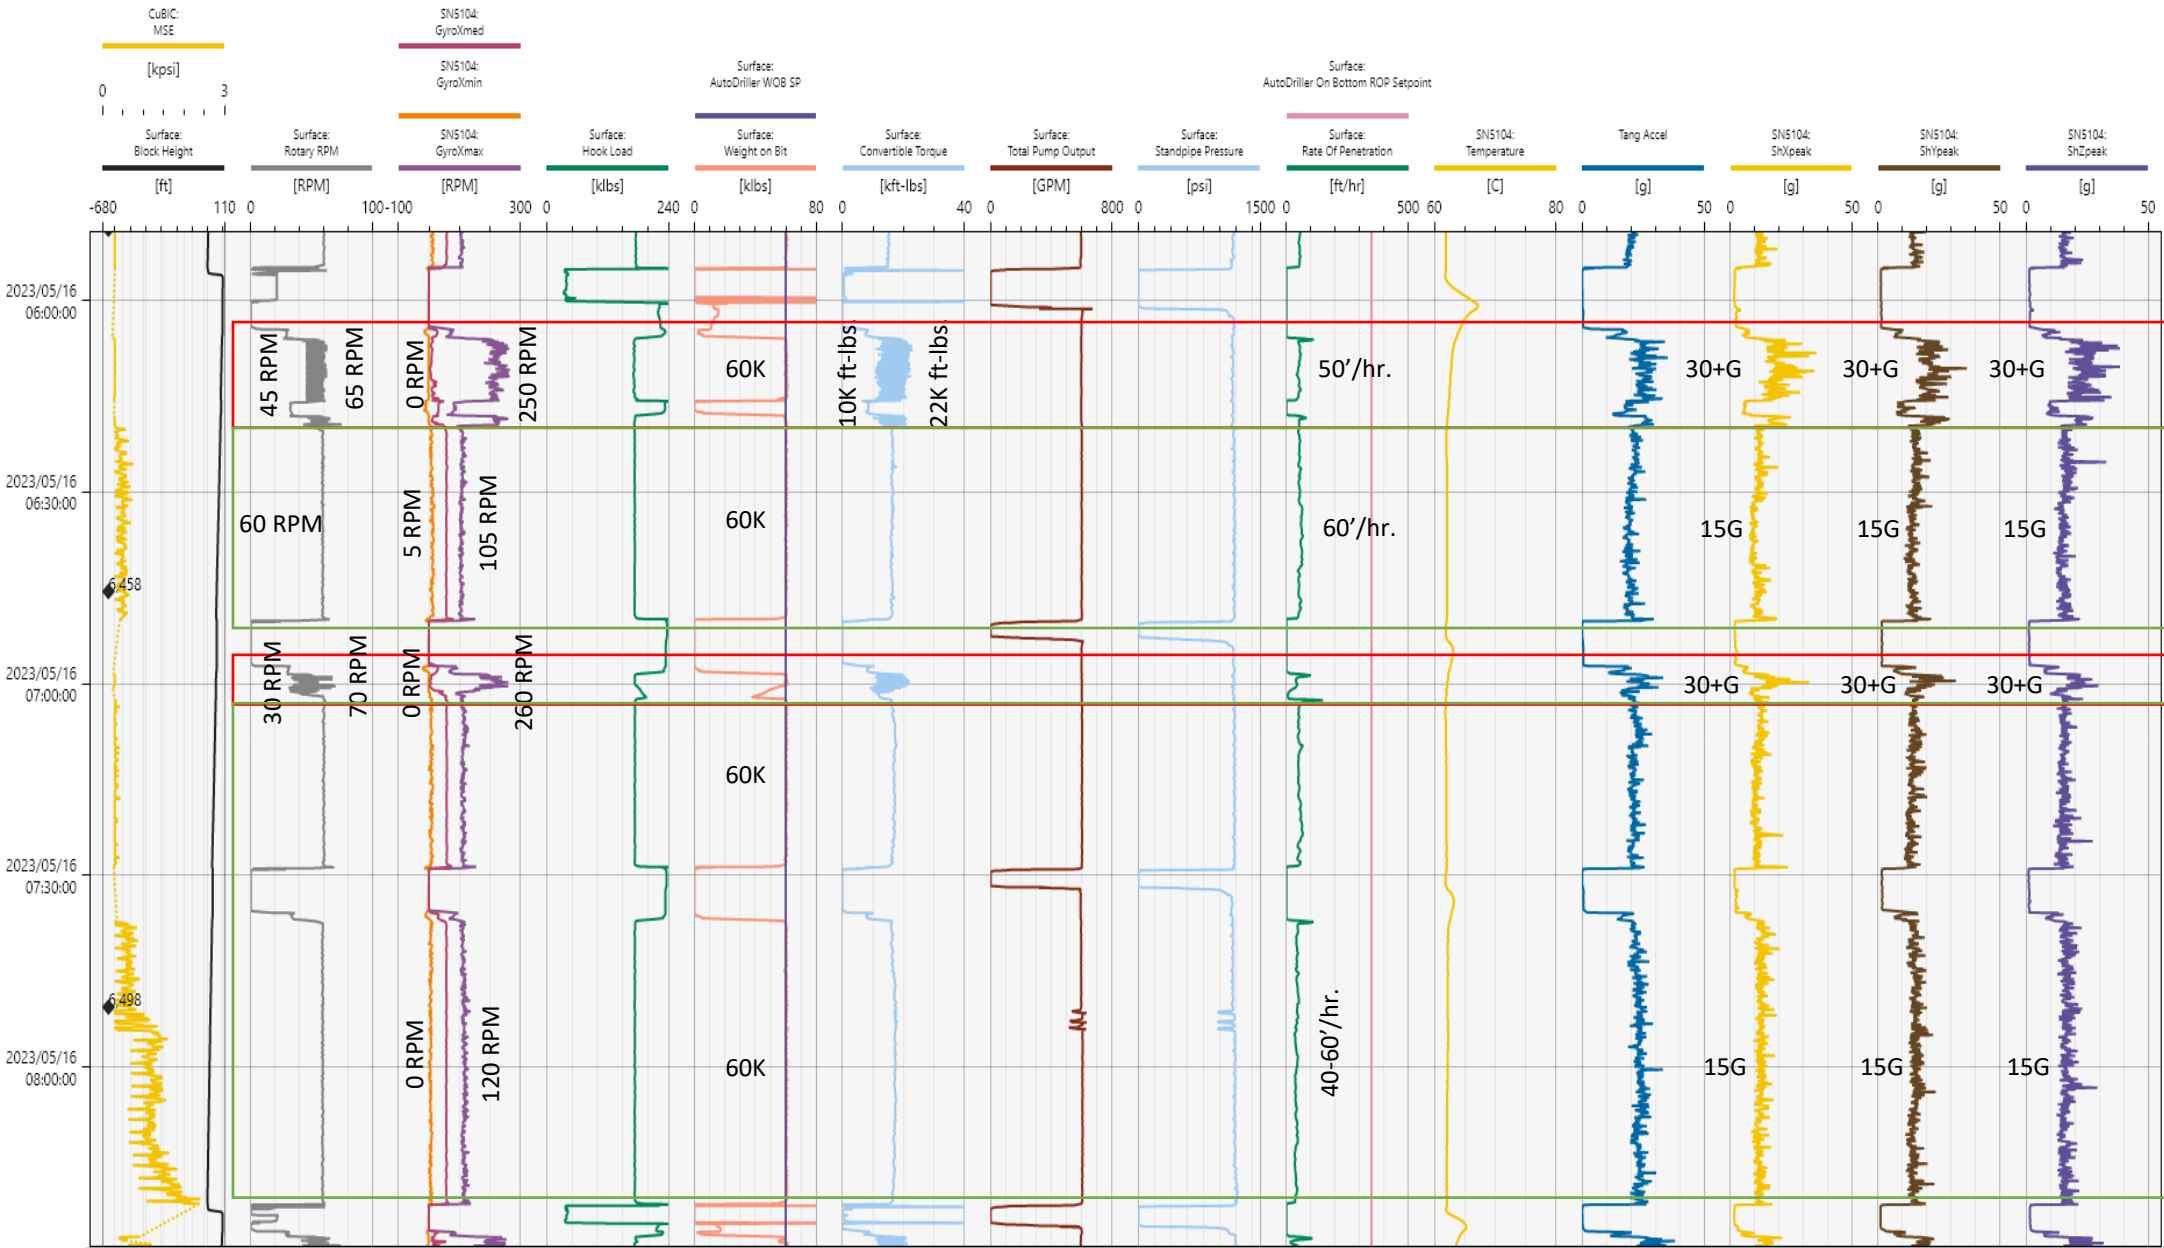
BHA #13 (6) – Stand Zoom

REVIT (ON) is inducing severe Stick-Slip and increased 3-axis Peak Shocks at bit.

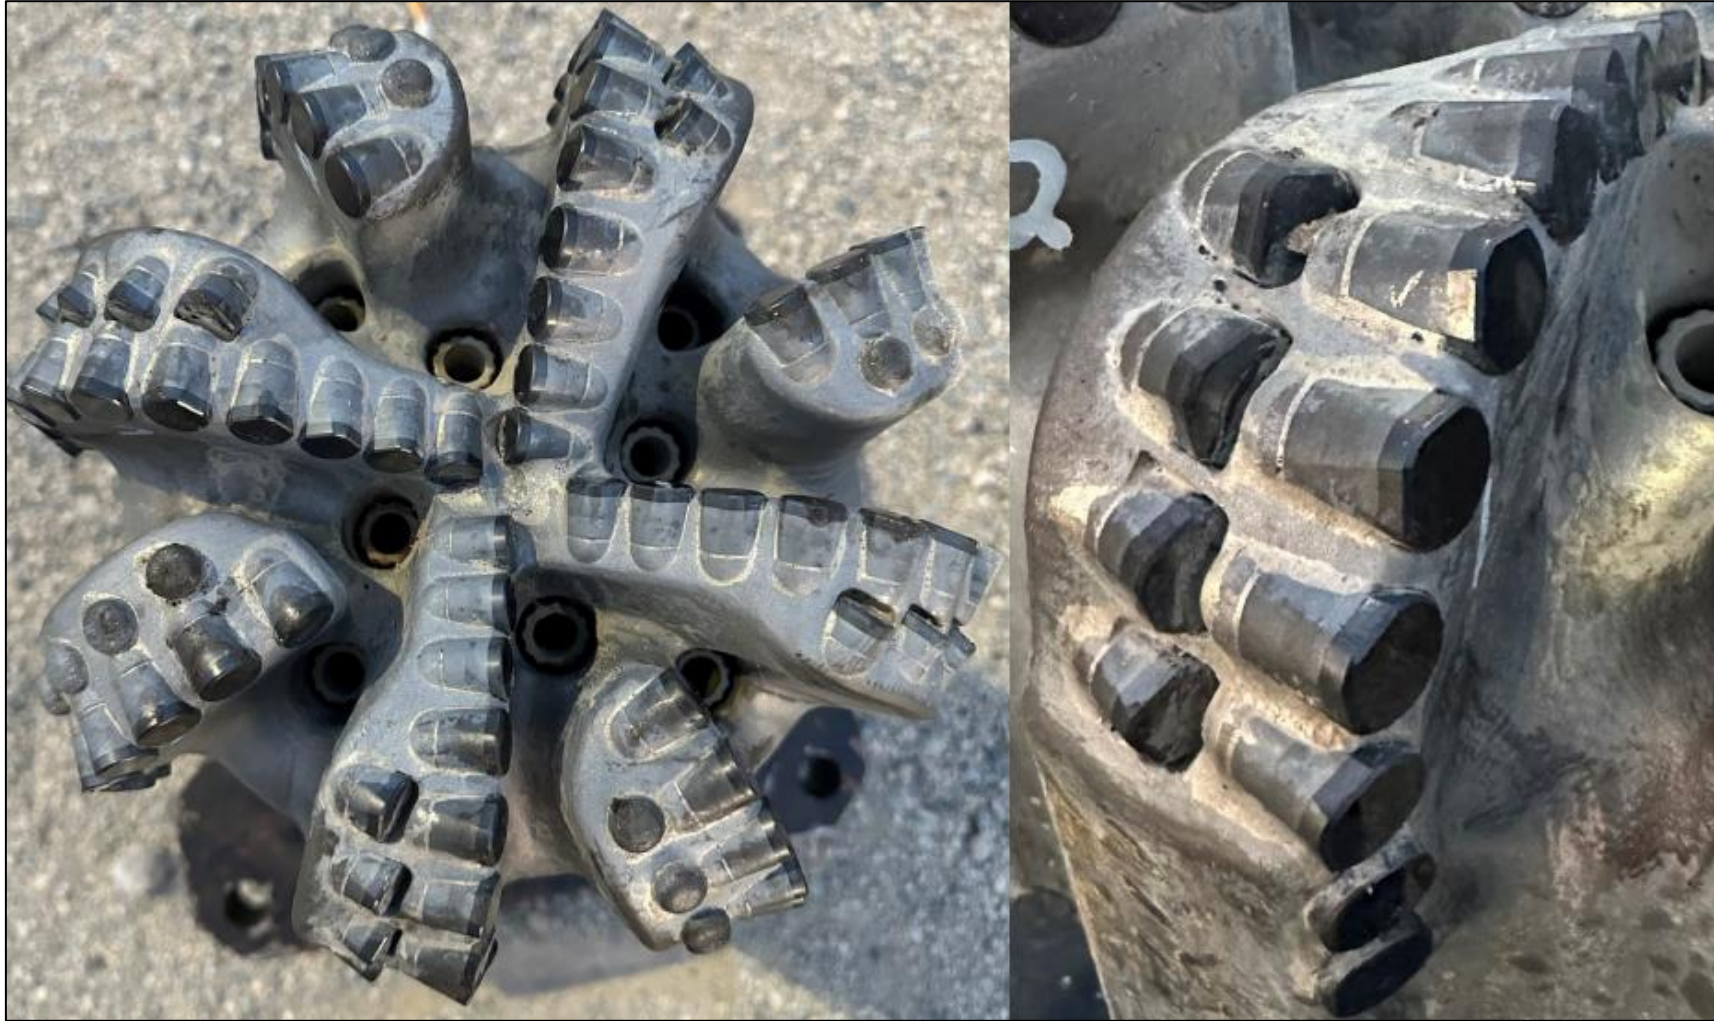
BHA #14 (7) HALO RSS NO MOTOR

ROP Limiter: Short run. Drilled the curve from 42 to 45 degrees.

DD commented that the bit was steerable and able to get the builds needed.

Pulled for MWD failure.

Solution: Figure out BHA vibration modeling to allow for mud motor to be ran.

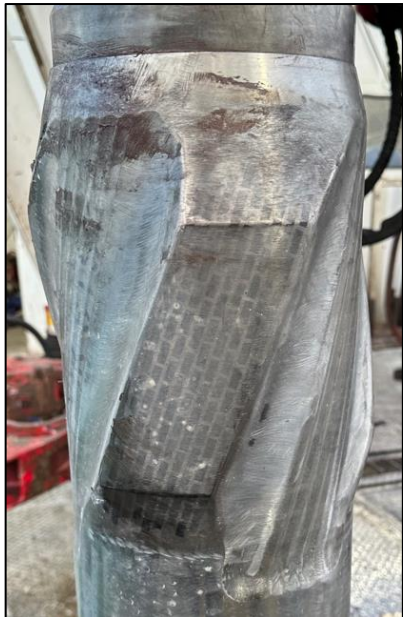
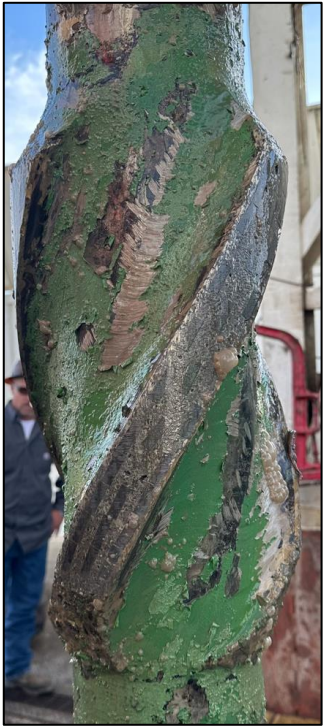
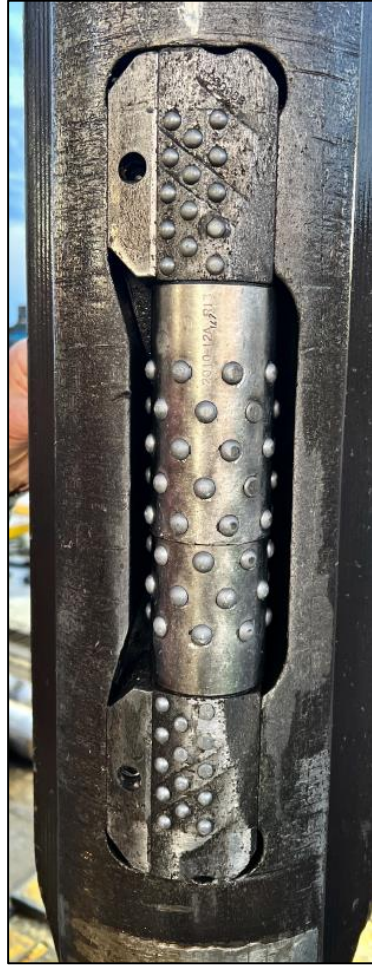
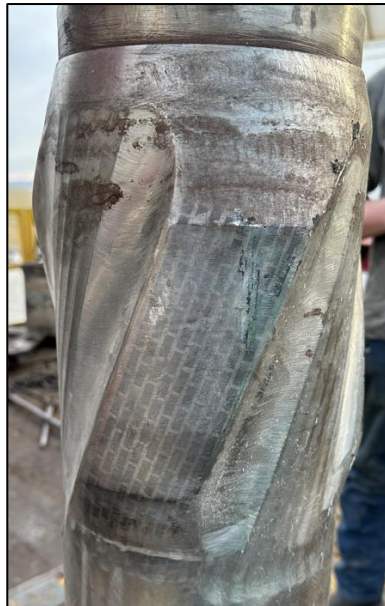
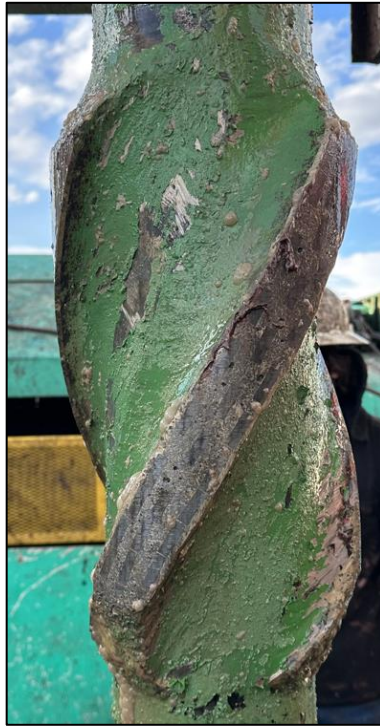
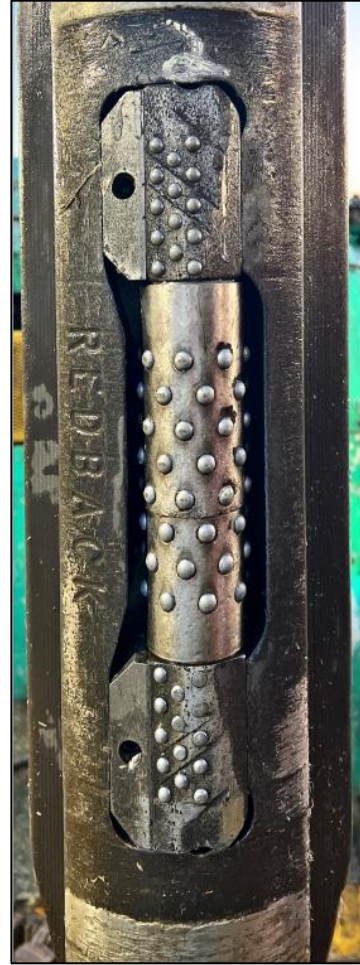
BHA #14 (7) HALO RSS NO MOTOR

Good condition.
