16B(78)-32 - 9.5in
BHAs #11 through #17

4: Directional BHA #4 HALO, 9 1/2" Hole section

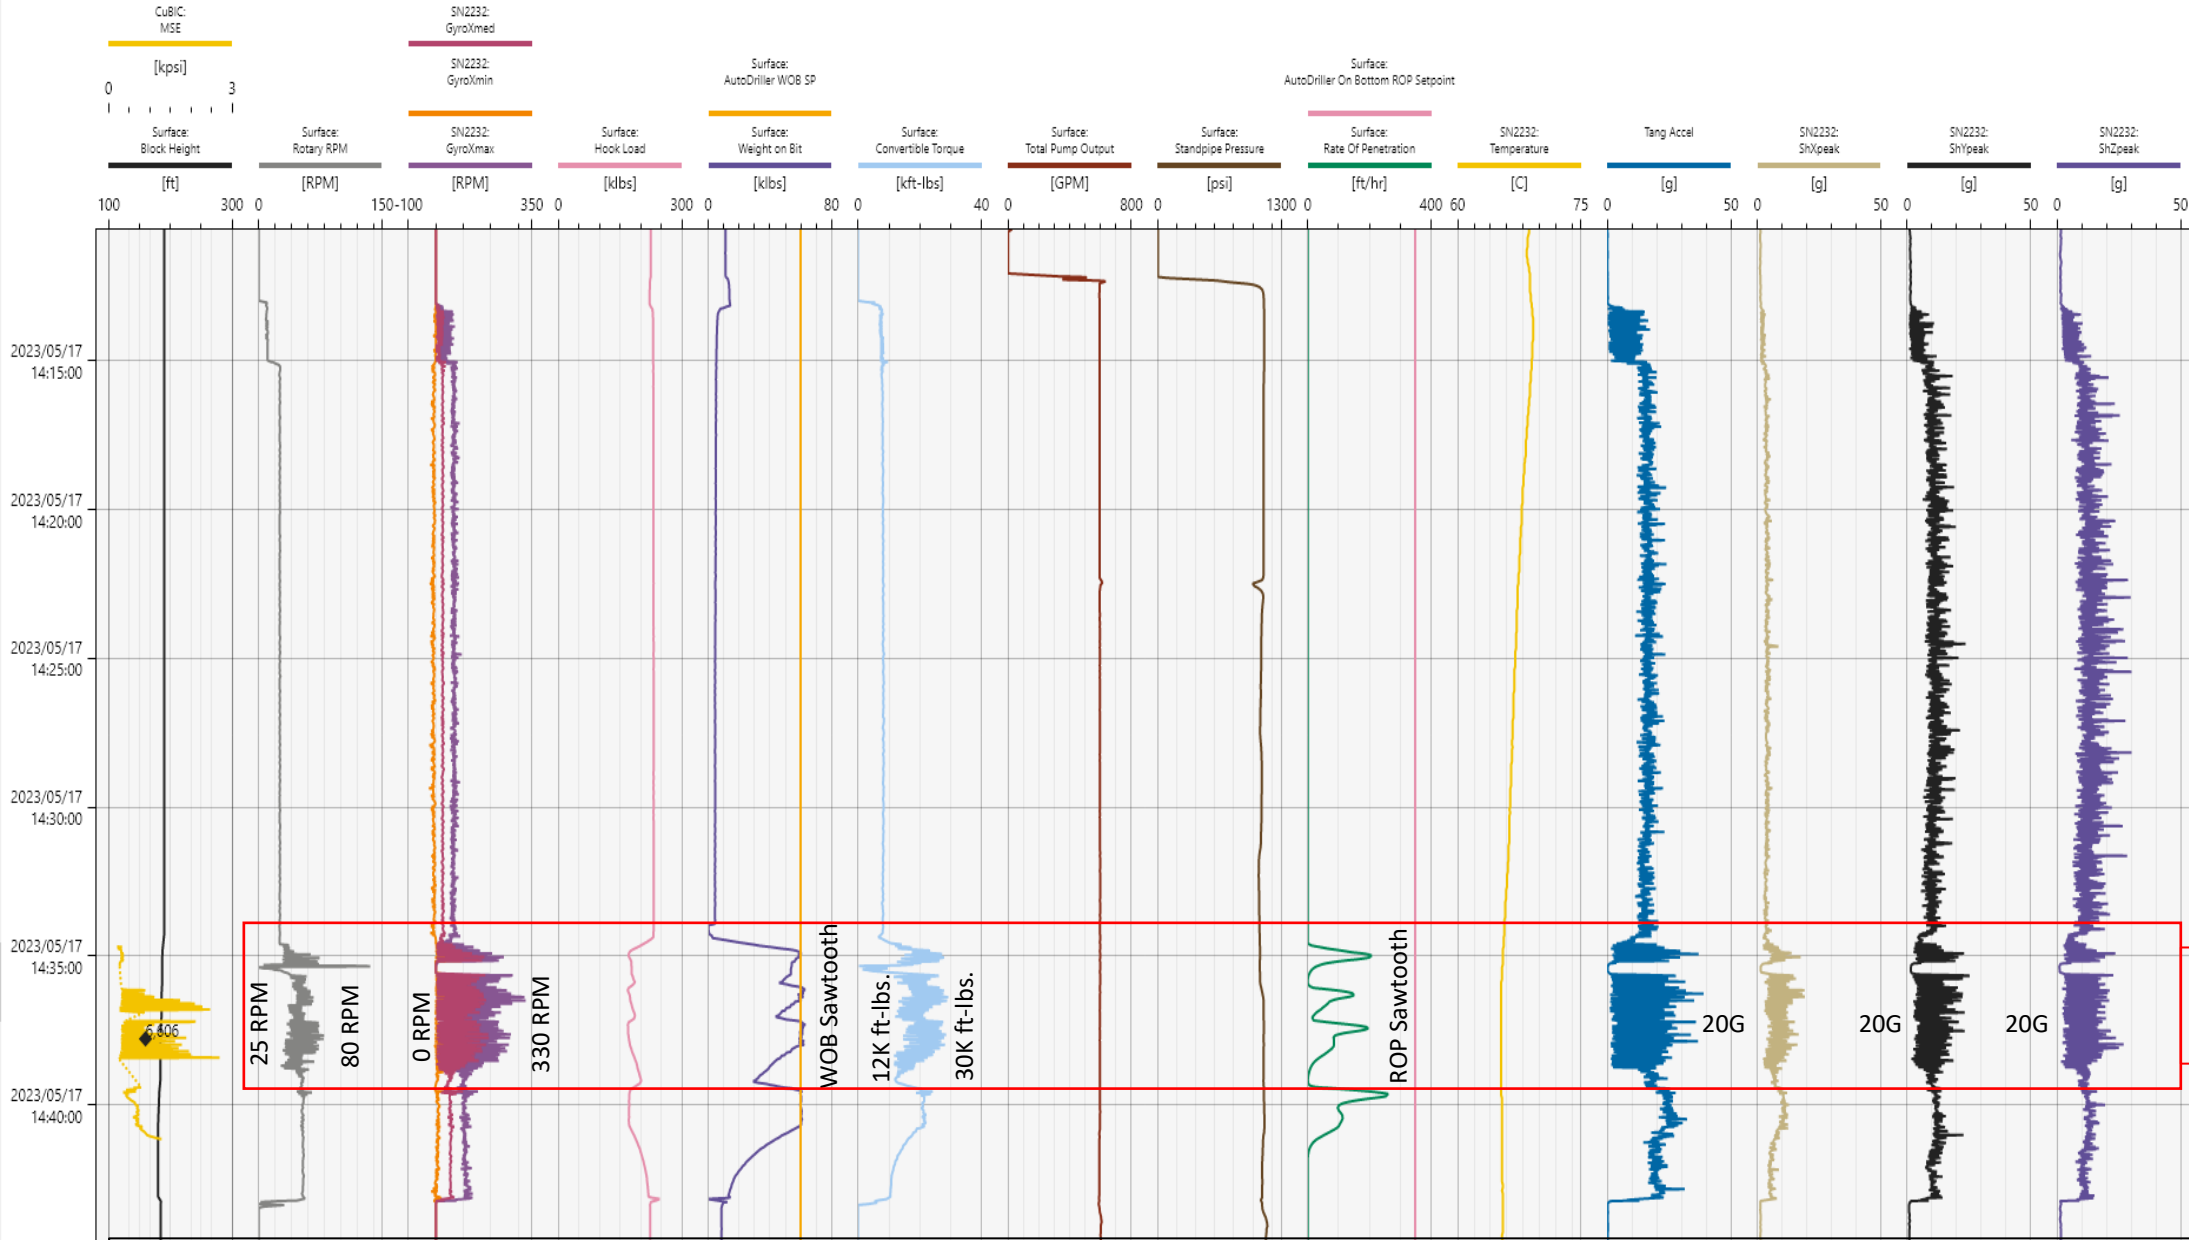
BHA #14 (7) – Stand Zoom

REVIT (ON) causing significant increase in Stick-Slip and 3-axis Peak Shocks increased.

REVIT/DAS? Enabled and driving torsional dysfunction.

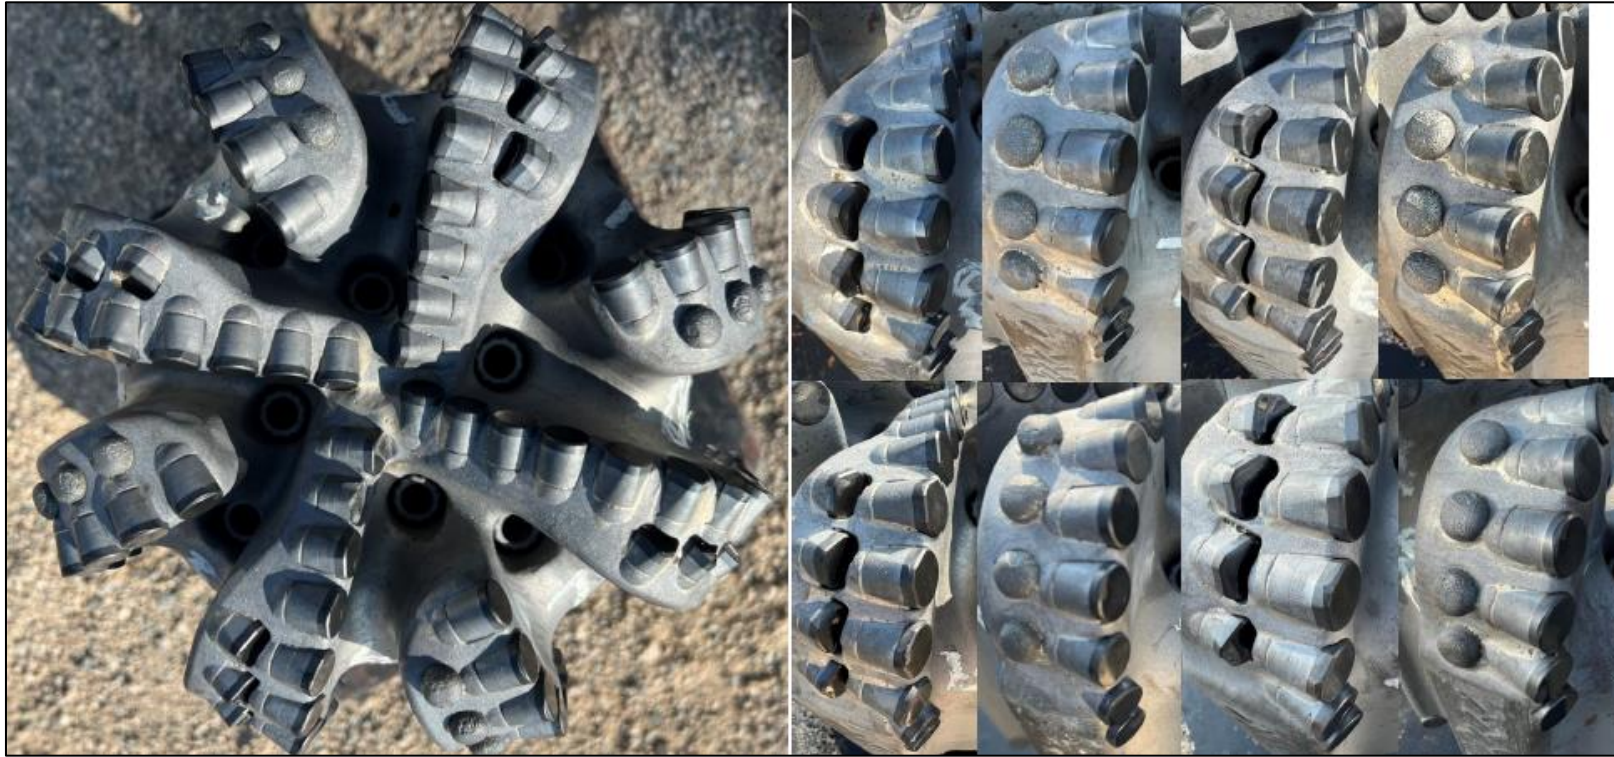
BHA #15 (8) HALO RSS NO MOTOR

ROP Limiter: Drilled the curve from 45 degrees to end of build. Tool vibrations are high due to Revit system errors.

Halo RSS ran without a motor due to high vibrations.

Revit system malfunction at 6,777 feet that caused variation in drilling plots.

Curve was still drilled efficiently with RSS system.

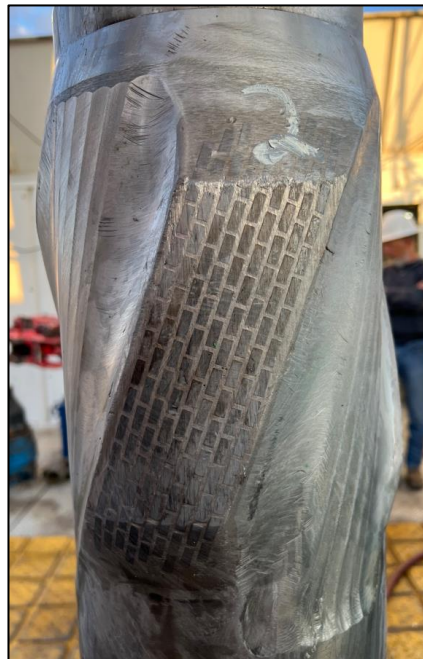
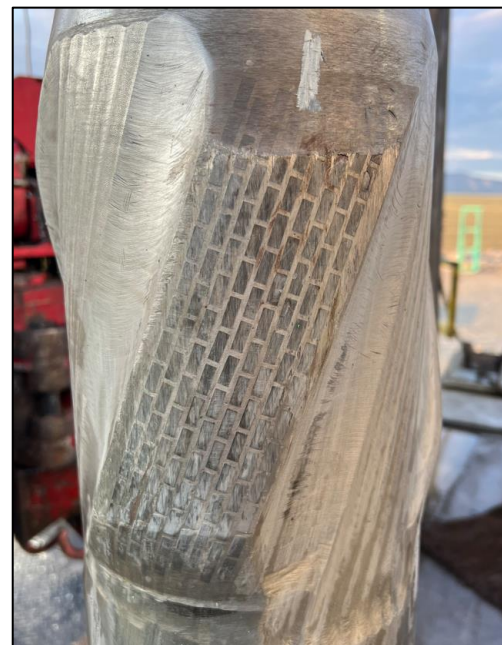
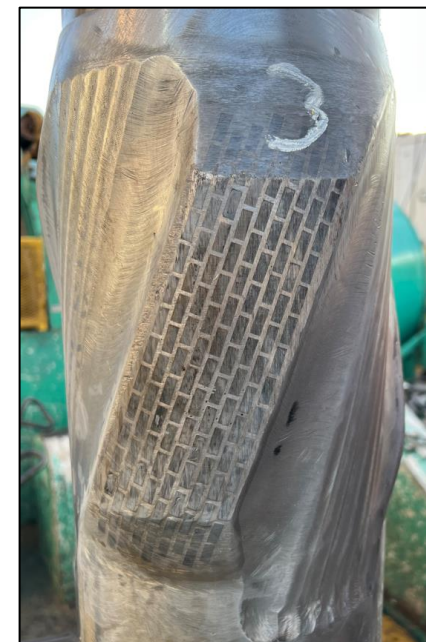
- Bit dynamics were normal for rotary assembly until rig surface control system enabled.
- Rig surface control system inducing torsional dynamics into drill string.
- Bit, HALO stab in good condition. No other photos available.
- POOH for MWD failure.

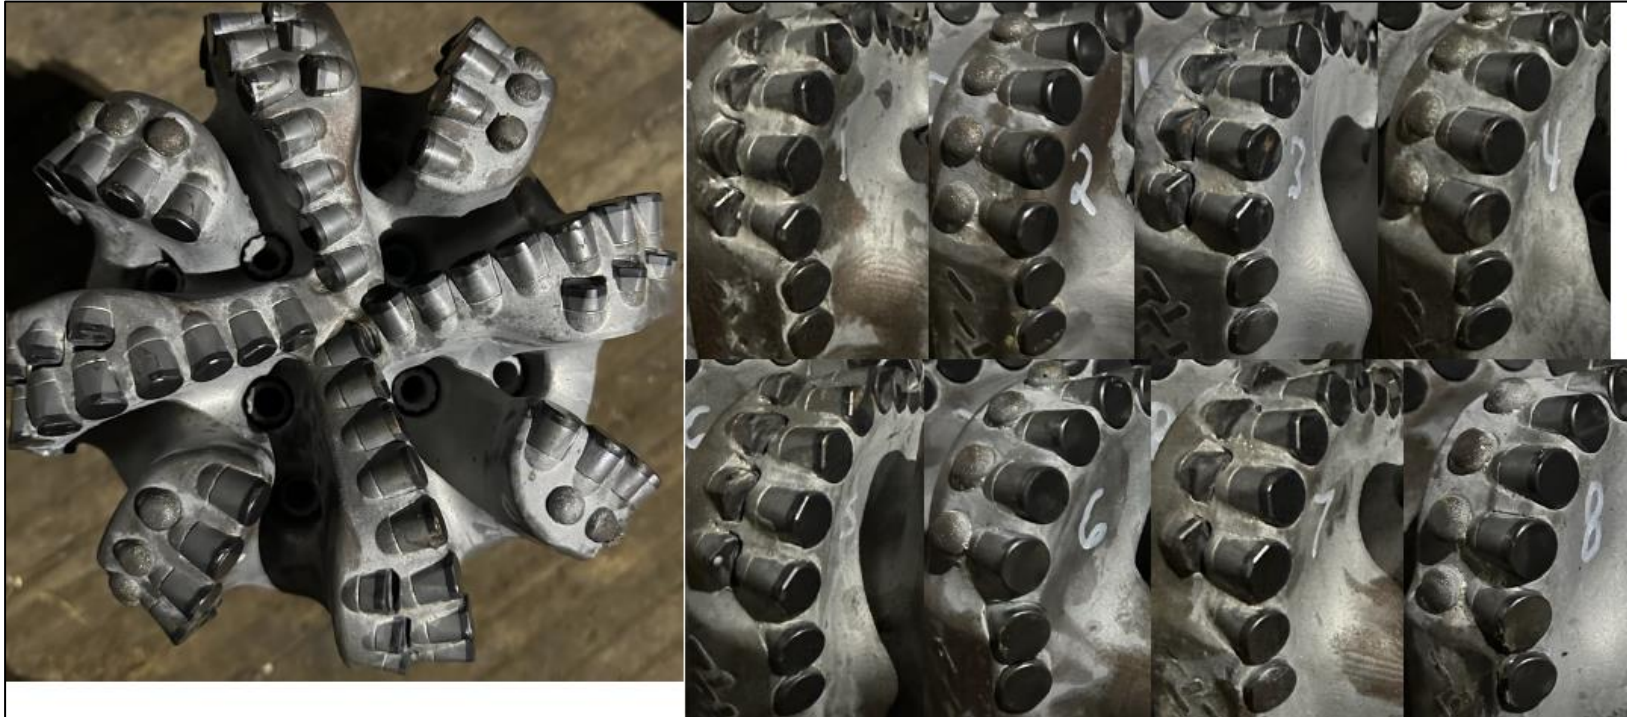
BHA #16 (9) HALO RSS NO MOTOR

ROP Limiter: WOB was not being zeroed every stand until 7,570'. You can see the ROP decline each consecutive stand until the issue was corrected. When corrected, MSE and ROP returned to baseline.

Tested 100% fresh water pill (@7,090') as well as a 50/50 fresh water/reserve pit pill (@7,420').

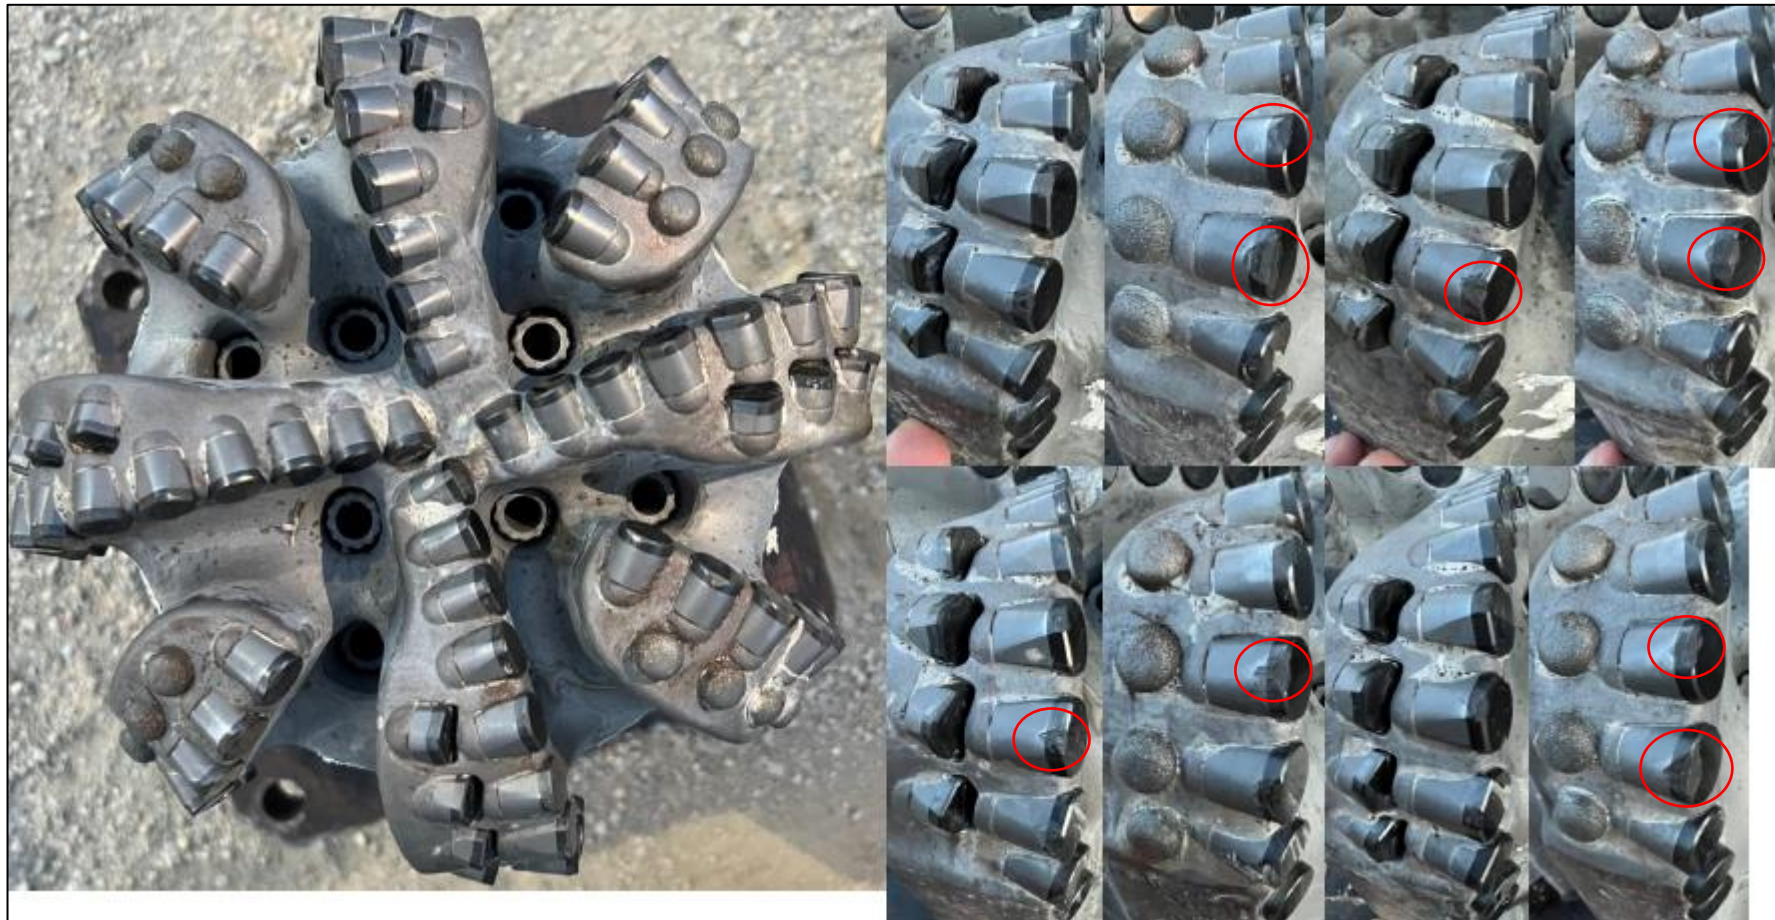
BHA #17 (10) STEERABLE MOTOR

ROP Limiter: BHA was ran with a 1° motor. The BHA wanted to build. Axial vibrations were high which could be due to limiting WOB and not getting enough DOC.

Step test at 7,670 did not change Downhole MSE much.

Solution: To deal with the build tendency, the next run will be ran with higher bit RPM's by increasing Flowrate and Rotary Speed.

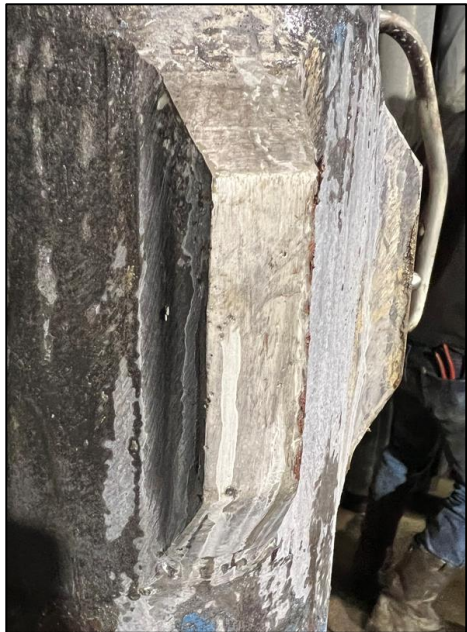
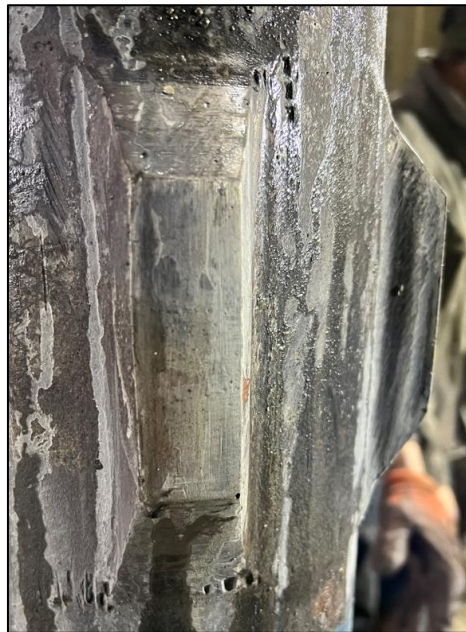
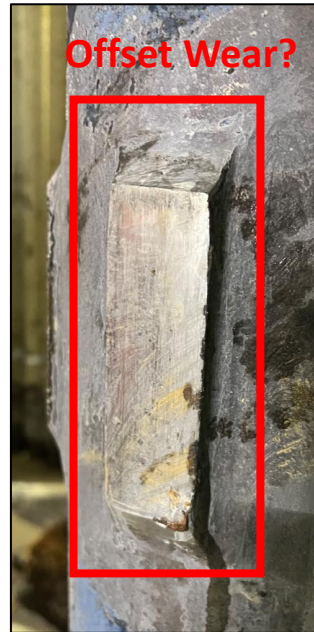
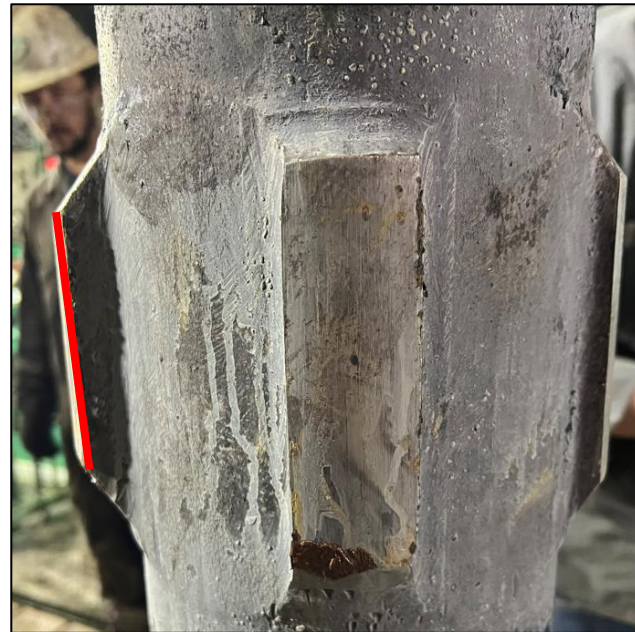
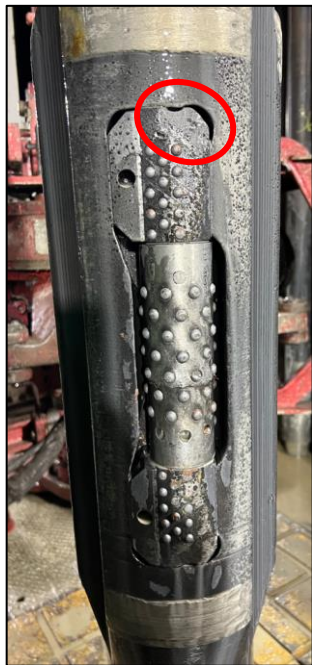
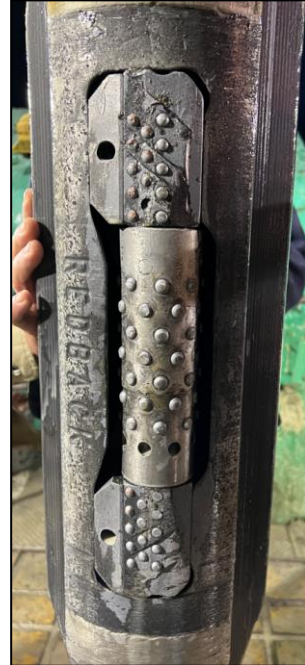
BHA #17 (10) STEERABLE MOTOR

- Offset wear on stabilizer.
- Bit shoulder cutters starting to wear.
- Bit dynamics are at highest when off bottom with pumps on and no surface rotation.
- Either bit whirl or unloaded bit grabbing on wellbore.
